# Access Compliance Report

## Public Rights-of-Way

### (Curb Ramps)

Intersection ID: 10033868	Main Street: PARHAM_PL	Cross Street: N/A	Location: W
ADA ID: 074B08E4C62E	Ramp Type: Perp	Initial Pass/Fail: Fail	Overall Compliance: No
Codes/Mitigation Info/Possible Solution		Field Measurements/Component Compliance	
Severity Score: 13.75

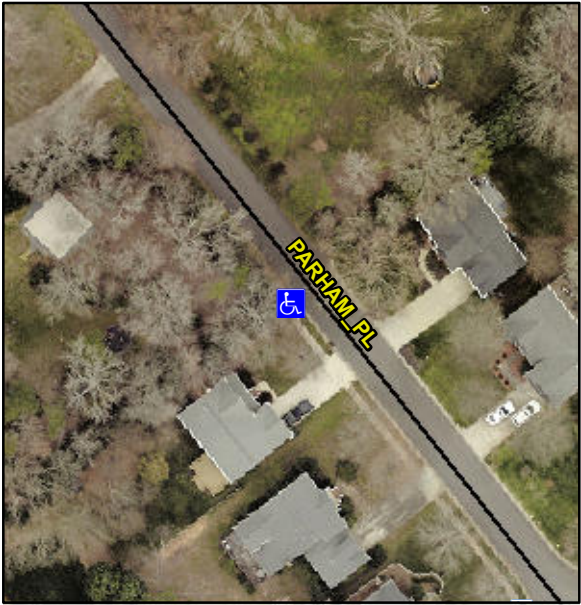
Possible Solutions:	Compliance	Description	Data	Compliance	Description	Data
	Remove & Replace Entire Ramp.	N/A	Ramp Length (in)	28.0	No	Ramp Slope (%)	11.6
		Yes	Ramp Width (in)	48.0	Yes	Ramp XSlope (%)	2.3
		N/A	Flare Type LT	N/A	N/A	Flare Type RT	N/A
		N/A	Flare Slope LT (%)	N/A	N/A	Flare Slope RT (%)	N/A
		N/A	Flare Traversable LT?	N/A	N/A	Flare Traversable RT?	N/A
		N/A	Landing Length (in)	N/A	N/A	DWS Provided?	N/A
		N/A	Landing Width (in)	N/A	N/A	DWS Contrast?	N/A
		N/A	Landing Slope (%)	N/A	N/A	DWS Length (in)	N/A
		N/A	Landing X Slope (%)	N/A	N/A	DWS Full Width?	N/A
<p>Surveyor Notes:</p> <p>N/A</p> <p>PROW/ADA:</p> <p>Not Found, R304.2.2</p>		N/A	Landing Curb? (Y/N)	N/A	N/A	DWS Offset (in)	N/A
		N/A	Shared Landing?	N/A			
		N/A	Gutter Ponding?	N/A	N/A	Gutter Slope (%)	N/A
		N/A	Gutter Lip Ht (in)	N/A	N/A	Gutter X Slope (%)	N/A
		N/A	Painted X Walk1?	No	N/A	Painted X Walk2?	N/A
			X Walk 1 Direction	To E		X Walk 2 Direction	N/A
