# Access Compliance Report

## Public Rights-of-Way

### (Curb Ramps)

Intersection ID: 14977	Main Street: BUCHANAN_ST	Cross Street: KENILWORTH_AV	Location: N
ADA ID: 075E1D4B078A	Ramp Type: Perp	Initial Pass/Fail: Fail	Overall Compliance: No
Severity Score: 26.25			
Codes/Mitigation Info/Possible Solution		Field Measurements/Component Compliance

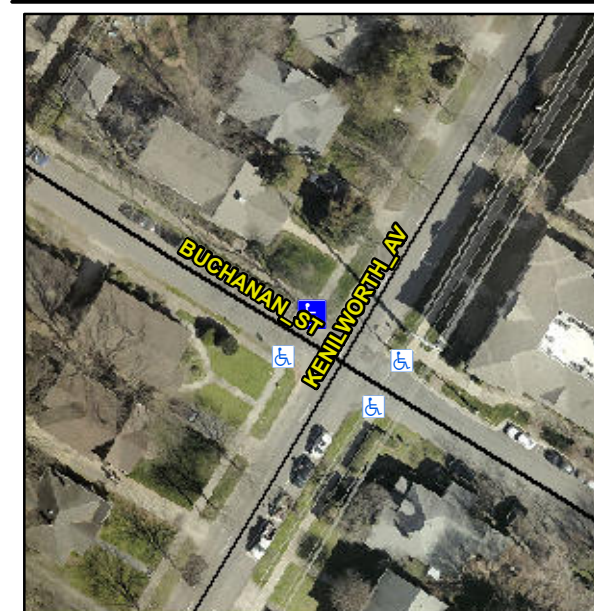
**Not Found, R304.2.2, R304.5.3**

Compliance	Description	Data	Compliance	Description	Data
N/A	Ramp Length (in)	30.0	No	Ramp Slope (%)	13.2
Yes	Ramp Width (in)	60.0	No	Ramp XSlope (%)	3.9
N/A	Flare Type LT	N/A	N/A	Flare Type RT	N/A
N/A	Flare Slope LT (%)	N/A	N/A	Flare Slope RT (%)	N/A
N/A	Flare Traversable LT?	N/A	N/A	Flare Traversable RT?	N/A
N/A	Landing Length (in)	N/A	N/A	DWS Provided?	N/A
N/A	Landing Width (in)	N/A	N/A	DWS Contrast?	N/A
N/A	Landing Slope (%)	N/A	N/A	DWS Length (in)	N/A
N/A	Landing X Slope (%)	N/A	N/A	DWS Full Width?	N/A
N/A	Landing Curb? (Y/N)	N/A	N/A	DWS Offset (in)	N/A
N/A	Shared Landing?	N/A			
N/A	Gutter Ponding?	N/A	N/A	Gutter Slope (%)	N/A
N/A	Gutter Lip Ht (in)	N/A	N/A	Gutter X Slope (%)	N/A
N/A	Painted X Walk1?	No	N/A	Painted X Walk2?	N/A
	X Walk 1 Direction	To SW		X Walk 2 Direction	N/A
N/A	X Walk 1 Width (in)	N/A	N/A	X Walk 2 Width (in)	N/A
	X Walk 1 Slope (%)	3.0		X Walk 2 Slope (%)	N/A
	X Walk 1 X Slope (%)	1.4		X Walk 2 X Slope (%)	N/A

N/A	Ramp inside XWalk1?	N/A	N/A	Ramp inside XWalk2?	N/A
	Road Slope (%)	N/A	N/A	Clear Space?	N/A
	Road X Slope (%)	N/A	N/A	Clear Space to XWalk (in)	N/A
N/A	Any Obstructions?	N/A	N/A	Storm Grate/Utility Hazard?	N/A
	Obstruction Type			Storm Grate/Utility Type	
		N/A			N/A
			Yes	Surface Condition? (G/P)	Good

**Remove & Replace Entire Ramp.**

Total Cost: \$ 1850.00
