Access Compliance Report

Public Rights-of-Way

(Curb Ramps)

| Intersection ID: 6481 | Main Street: LOTHAR RIDGE LN | Cross Street: SLATER SPRINGS DR | Location: NW |

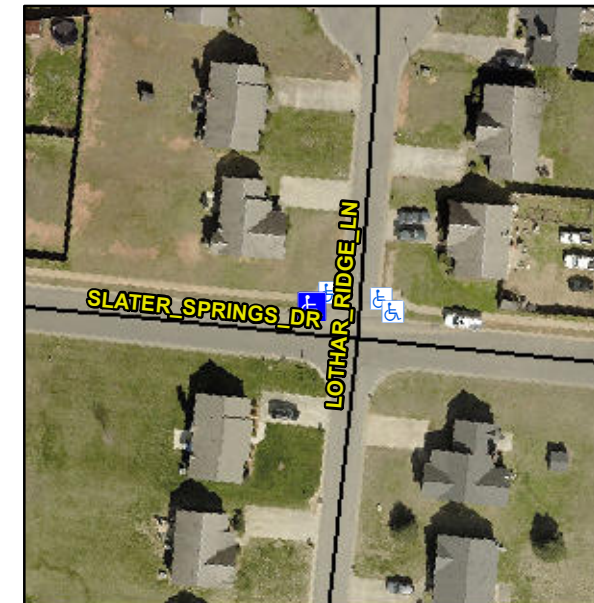
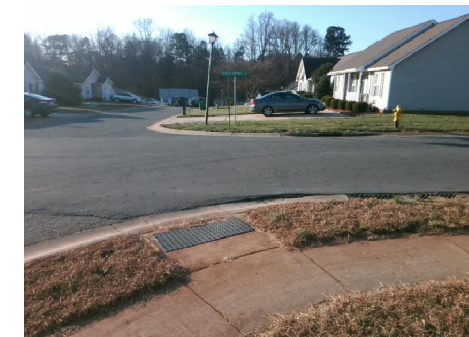
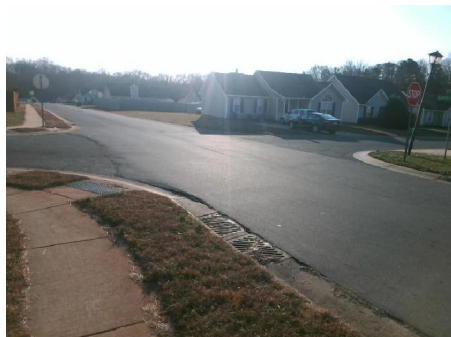
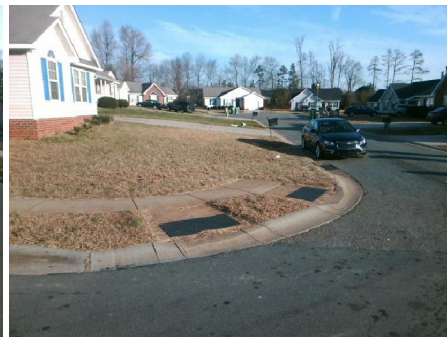
| ADA ID: 075ED09ED236 | Ramp Type: Perp | Initial Pass/Fail: Fail | Overall Compliance: No |

Not Found, R304.5.1, R304.5.3

| Compliance | Description | Data | Compliance | Description | Data |
|---|---|---|---|---|---|
| N/A | Ramp Length (in) | 50.5 | Yes | Ramp Slope (%) | 7.6 |
| No | Ramp Width (in) | 42.5 | No | Ramp XSlope (%) | 2.3 |

Remove & Replace Entire Ramp.
