Access Compliance Report Public Rights-of-Way (Curb Ramps)

Intersection ID: 12126	Main Street: KIMMERLY_GLEN_LN			Cross Street: N_SHARON_AMITY_RD					Location:	S
ADA ID: 076493FFC90B	Ramp Type: PerpDiag			Initial Pass/Fail: Fail Overall Compliance: No						12.5
Codes/Mitigation Info/Possible Solution				Field Measurements/Component Compliance						
		Possible Solutions:			Compliance Description		Data	Comp	liance Description	Data
California (Remove & Replace Curb Ramp Two New Directional Ramps or Equivalent.	amp Witl	h	N/A	Ramp Length (in)	60.0	No	Ramp Slope (%)	10.5

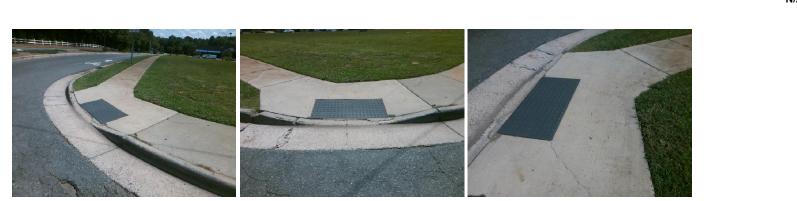
•		Yes	Ramp Width (in)	50.0	Yes	Ramp XSlope (%)	0.5
the second second					N/A	Flare Type LT	N/A	N/A	Flare Type RT	N/A
					N/A	Flare Slope LT (%)	N/A	N/A	Flare Slope RT (%)	N/A
A A A					N/A	Flare Traversable LT?	N/A	N/A	Flare Traversable RT?	N/A

Stop Condition-Street 1	None					Road Slope (%)	0.9	N/A	Clear Space?	N/A
						Road X Slope (%)	1.9	N/A	Clear Space to XWalk (in)	N/A
					N/A	Any Obstructions?	N/A	N/A	Storm Grate/Utility Hazard?	N/A
		Total Cost:	\$ 3200	0.00		Obstruction Type			Storm Grate/Utility Type	
							N/A			N/A
