Access Compliance Report

Public Rights-of-Way

(Curb Ramps)

| Intersection ID: 48391 | Main Street: RICHARD_ROZZELLE_DR | Cross Street: JOE_MORRISON_LN | Location: SW |

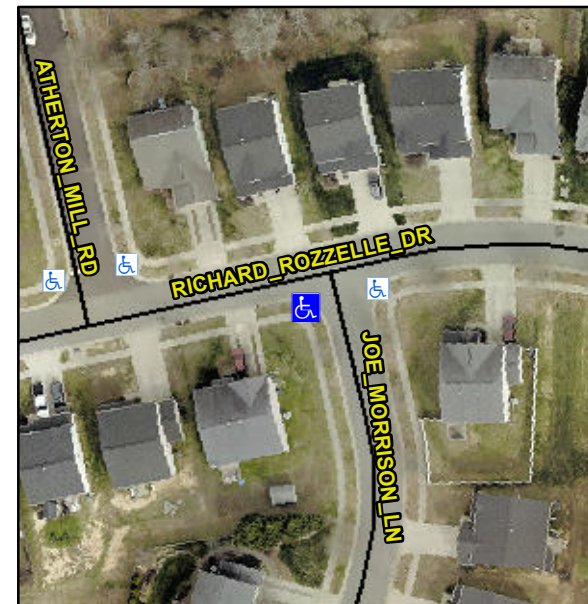
R304.5.1, R304.5.3

| Compliance | Description | Data | Compliance | Description | Data |
|---|---|---|---|---|---|
| N/A | Ramp Length (in) | 72.5 | Yes | Ramp Slope (%) | 6.9 |
| No | Ramp Width (in) | 47.0 | No | Ramp XSlope (%) | 5.3 |

Remove & Replace Curb Ramp With Two New Directional Ramps or Equivalent.

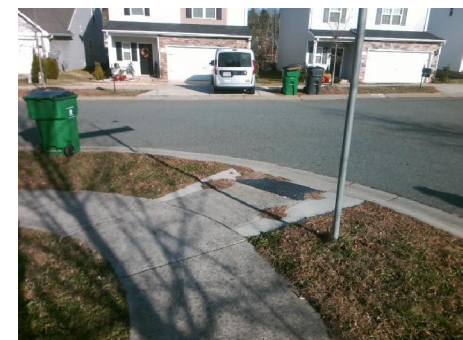
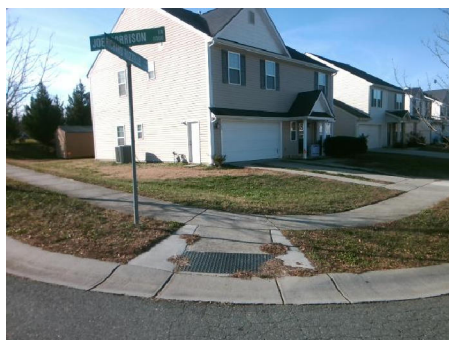
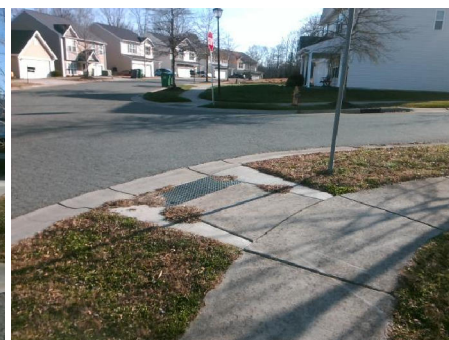
| Compliance | Description | Data | Compliance | Description | Data |
|---|---|---|---|---|---|
| | | Yes | | Surface Condition? (G/P) | Good |
