# Access Compliance Report

## Public Rights-of-Way

### (Curb Ramps)

| Intersection ID: 53704 | Main Street: MILLSTREAM RIDGE DR | Cross Street: CHRISTENBURY RD | Location: | N |

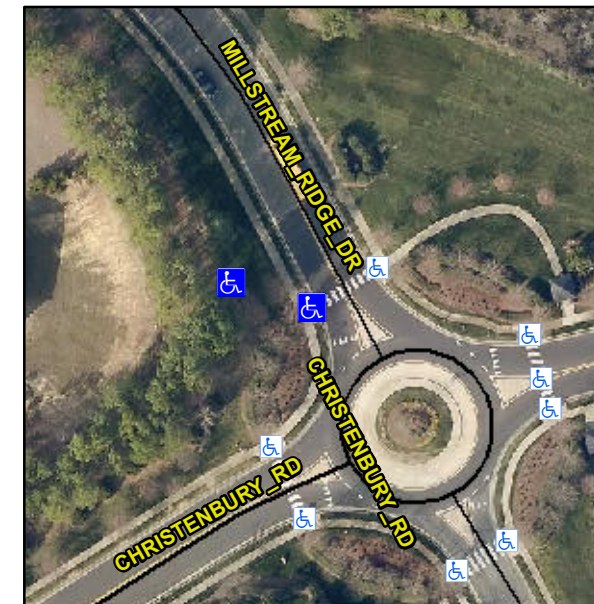
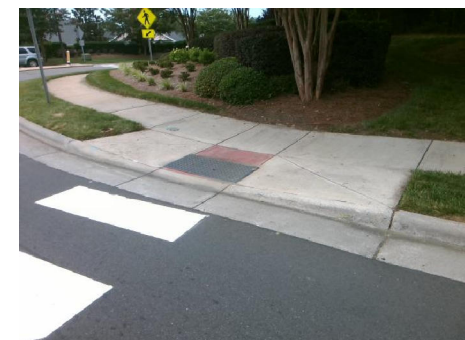
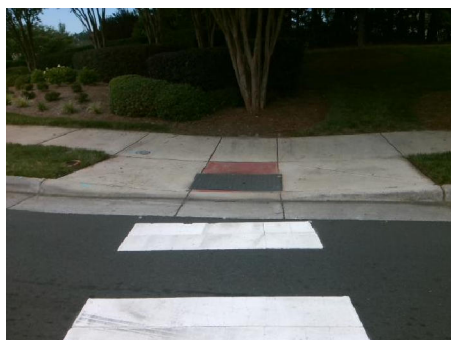
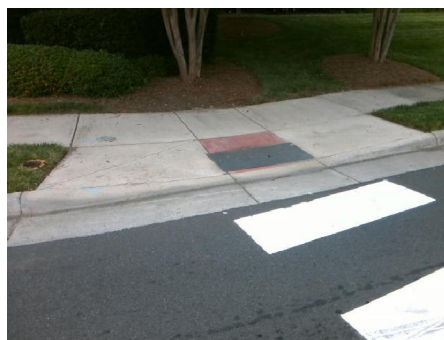
| ADA ID: 076680086EC9 | Ramp Type: BlendTrans1 | Initial Pass/Fail: Fail | Overall Compliance: No | Severity Score: 10 |

**Not Found, R304.5.1, R304.5.3**

| Compliance | Description | Data | Compliance | Description | Data |
|---|---|---|---|---|---|
| No | Ramp Width (in) | 45.0 | No | BlendTrans XSlope (%) | 2.2 |
| | | | No | Curb Slope (%) | 12.4 |

**Remove & Replace Curb Ramp With Two New Directional Ramps or Equivalent.**

Total Cost: \$ 3200.00
