# Access Compliance Report

## Public Rights-of-Way

### (Curb Ramps)

Intersection ID: N/A	Main Street: INVERNESS_BAY_RD	Cross Street: PERTH_MOOR_RD	Location: NW
ADA ID: 076F33637515	Ramp Type: Perp	Initial Pass/Fail: Fail	Overall Compliance: No
Severity Score: 21.25			
Codes/Mitigation Info/Possible Solution		Field Measurements/Component Compliance

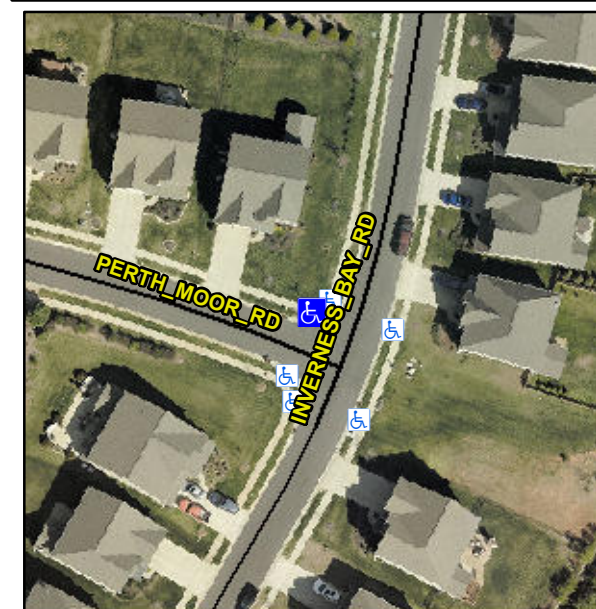
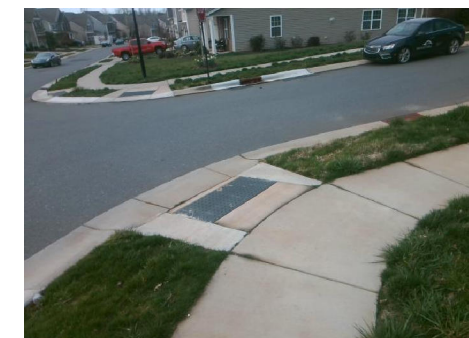
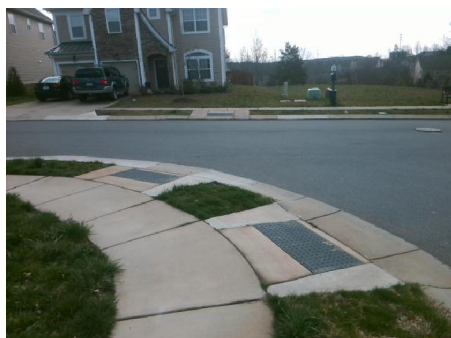
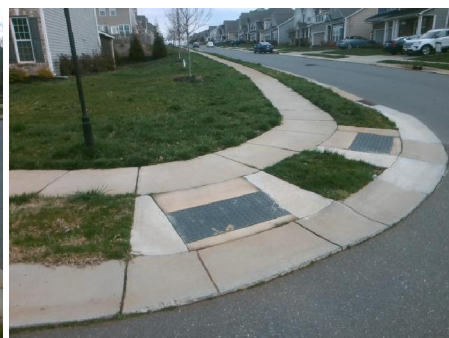
Compliance	Description	Data	Compliance	Description	Data
N/A	Ramp Length (in)	48.0	No	Ramp Slope (%)	11.6
No	Ramp Width (in)	41.0	Yes	Ramp XSlope (%)	1.2
N/A	Flare Type LT	N/A	N/A	Flare Type RT	N/A
N/A	Flare Slope LT (%)	N/A	N/A	Flare Slope RT (%)	N/A
N/A	Flare Traversable LT?	N/A	N/A	Flare Traversable RT?	N/A
N/A	Landing Length (in)	N/A	N/A	DWS Provided?	N/A
N/A	Landing Width (in)	N/A	N/A	DWS Contrast?	N/A
N/A	Landing Slope (%)	N/A	N/A	DWS Length (in)	N/A
N/A	Landing X Slope (%)	N/A	N/A	DWS Full Width?	N/A
N/A	Landing Curb? (Y/N)	N/A	N/A	DWS Offset (in)	N/A
N/A	Shared Landing?	N/A			
N/A	Gutter Ponding?	N/A	N/A	Gutter Slope (%)	N/A
N/A	Gutter Lip Ht (in)	1.5	N/A	Gutter X Slope (%)	N/A
N/A	Painted X Walk1?	No	N/A	Painted X Walk2?	N/A
	X Walk 1 Direction	To SW		X Walk 2 Direction	N/A
N/A	X Walk 1 Width (in)	N/A	N/A	X Walk 2 Width (in)	N/A
	X Walk 1 Slope (%)	1.6		X Walk 2 Slope (%)	N/A
	X Walk 1 X Slope (%)	1.1		X Walk 2 X Slope (%)	N/A

N/A	Ramp inside XWalk1?	N/A	N/A	Ramp inside XWalk2?	N/A
	Road Slope (%)	N/A	N/A	Clear Space?	N/A
	Road X Slope (%)	N/A	N/A	Clear Space to XWalk (in)	N/A
N/A	Any Obstructions?	N/A	N/A	Storm Grate/Utility Hazard?	N/A
	Obstruction Type			Storm Grate/Utility Type	
		N/A			N/A
			Yes	Surface Condition? (G/P)	Good

Possible Solutions:

**Remove & Replace Entire Ramp.**

**R304.5.1, R304.2.2**
