# Access Compliance Report

## Public Rights-of-Way

### (Curb Ramps)

Intersection ID: 43364	Main Street: PROSPERITY_VIEW_DR	Cross Street: HIGHLAND_COMMONS_RD	Location: E
ADA ID: 0774165471FB	Ramp Type: PerpDiag	Initial Pass/Fail: Fail	Overall Compliance: No
Severity Score: 8.75			
Codes/Mitigation Info/Possible Solution		Field Measurements/Component Compliance

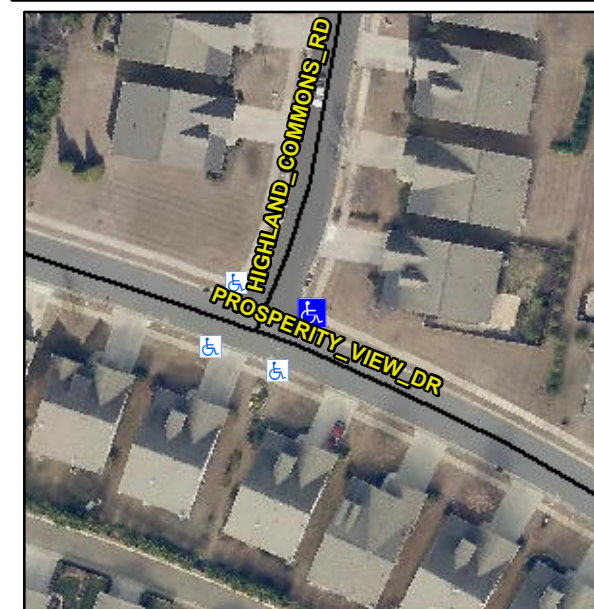
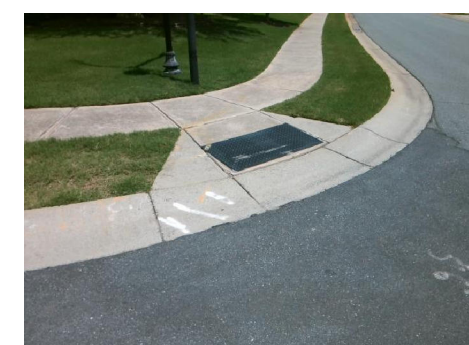
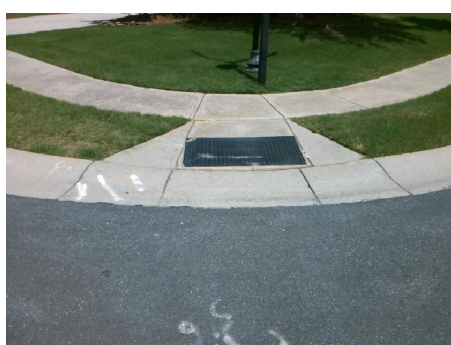
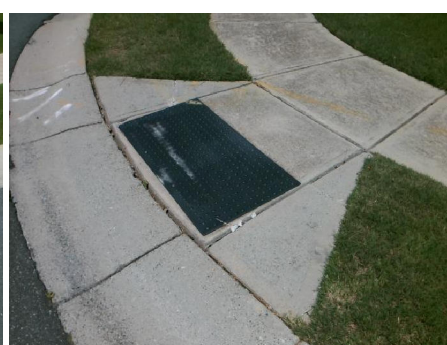
Compliance	Description	Data	Compliance	Description	Data
N/A	Ramp Length (in)	48.0	Yes	Ramp Slope (%)	6.9
No	Ramp Width (in)	45.0	Yes	Ramp XSlope (%)	0.9
N/A	Flare Type LT	N/A	N/A	Flare Type RT	N/A
N/A	Flare Slope LT (%)	N/A	N/A	Flare Slope RT (%)	N/A
N/A	Flare Traversable LT?	N/A	N/A	Flare Traversable RT?	N/A
N/A	Landing Length (in)	N/A	N/A	DWS Provided?	N/A
N/A	Landing Width (in)	N/A	N/A	DWS Contrast?	N/A
N/A	Landing Slope (%)	N/A	N/A	DWS Length (in)	N/A
N/A	Landing X Slope (%)	N/A	N/A	DWS Full Width?	N/A
N/A	Landing Curb? (Y/N)	N/A	N/A	DWS Offset (in)	N/A
N/A	Shared Landing?	N/A			
N/A	Gutter Ponding?	N/A	N/A	Gutter Slope (%)	N/A
N/A	Gutter Lip Ht (in)	N/A	N/A	Gutter X Slope (%)	N/A
N/A	Painted X Walk1?	No	N/A	Painted X Walk2?	No
	X Walk 1 Direction	To NW		X Walk 2 Direction	To SW
N/A	X Walk 1 Width (in)	N/A	N/A	X Walk 2 Width (in)	N/A
	X Walk 1 Slope (%)	3.1		X Walk 2 Slope (%)	0.8
	X Walk 1 X Slope (%)	1.0		X Walk 2 X Slope (%)	1.4

N/A	Ramp inside XWalk1?	N/A	N/A	Ramp inside XWalk2?	N/A
	Road Slope (%)	0.1	N/A	Clear Space?	N/A
	Road X Slope (%)	1.5	N/A	Clear Space to XWalk (in)	N/A
N/A	Any Obstructions?	N/A	N/A	Storm Grate/Utility Hazard?	N/A
	Obstruction Type			Storm Grate/Utility Type	
		N/A			N/A
			Yes	Surface Condition? (G/P)	Good

**Remove & Replace Curb Ramp With Two New Directional Ramps or Equivalent.**

**Not Found, R304.5.1**
