Access Compliance Report

Public Rights-of-Way

(Curb Ramps)

Intersection ID: 46470	Main Street: CRANDON_DR	Cross Street: PEACH_BUD_LN	Location: SE
ADA ID: 07753CBFF2B1	Ramp Type: PerpDiag	Initial Pass/Fail: Fail	Overall Compliance: No
Severity Score: 33.75			
Codes/Mitigation Info/Possible Solution		Field Measurements/Component Compliance

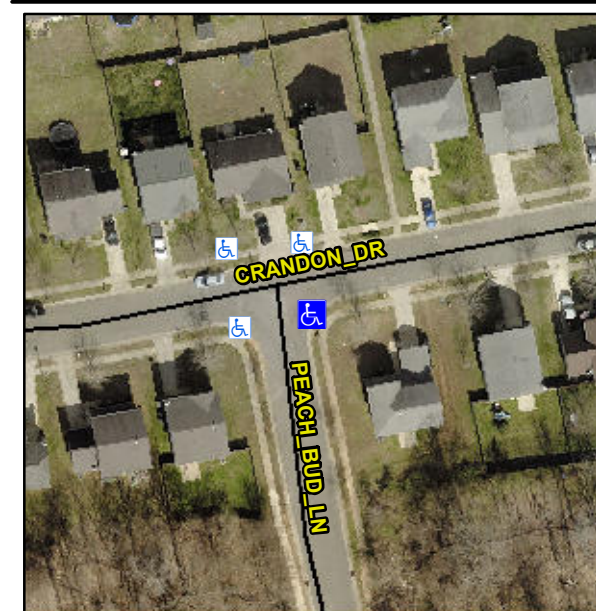
Not Found, R304.5.1, R304.2.2, R304.5.3

Compliance	Description	Data	Compliance	Description	Data
N/A	Ramp Length (in)	44.5	No	Ramp Slope (%)	8.5
No	Ramp Width (in)	46.0	No	Ramp XSlope (%)	5.5
N/A	Flare Type LT	N/A	N/A	Flare Type RT	N/A
N/A	Flare Slope LT (%)	N/A	N/A	Flare Slope RT (%)	N/A
N/A	Flare Traversable LT?	N/A	N/A	Flare Traversable RT?	N/A
N/A	Landing Length (in)	N/A	N/A	DWS Provided?	N/A
N/A	Landing Width (in)	N/A	N/A	DWS Contrast?	N/A
N/A	Landing Slope (%)	N/A	N/A	DWS Length (in)	N/A
N/A	Landing X Slope (%)	N/A	N/A	DWS Full Width?	N/A
N/A	Landing Curb? (Y/N)	N/A	N/A	DWS Offset (in)	N/A
N/A	Shared Landing?	N/A			
N/A	Gutter Ponding?	N/A	N/A	Gutter Slope (%)	N/A
N/A	Gutter Lip Ht (in)	N/A	N/A	Gutter X Slope (%)	N/A
N/A	Painted X Walk1?	No	N/A	Painted X Walk2?	No
	X Walk 1 Direction	To N		X Walk 2 Direction	To W
N/A	X Walk 1 Width (in)	N/A	N/A	X Walk 2 Width (in)	N/A
	X Walk 1 Slope (%)	3.5		X Walk 2 Slope (%)	1.6
	X Walk 1 X Slope (%)	2.8		X Walk 2 X Slope (%)	2.5

N/A	Ramp inside XWalk1?	N/A	N/A	Ramp inside XWalk2?	N/A
	Road Slope (%)	4.0	N/A	Clear Space?	N/A
	Road X Slope (%)	3.9	N/A	Clear Space to XWalk (in)	N/A
N/A	Any Obstructions?	N/A	N/A	Storm Grate/Utility Hazard?	N/A
	Obstruction Type			Storm Grate/Utility Type	
		N/A			N/A
			Yes	Surface Condition? (G/P)	Good

Remove & Replace Curb Ramp With Two New Directional Ramps or Equivalent.
