# Access Compliance Report

## Public Rights-of-Way

### (Curb Ramps)

Intersection ID: 10003849	Main Street: DIXIE_RIVER_RD	Cross Street: NEW_FASHION_WY	Location: SE
ADA ID: 077587275AE4	Ramp Type: PerpDiag	Initial Pass/Fail: Fail	Overall Compliance: No
		Severity Score: 22.5

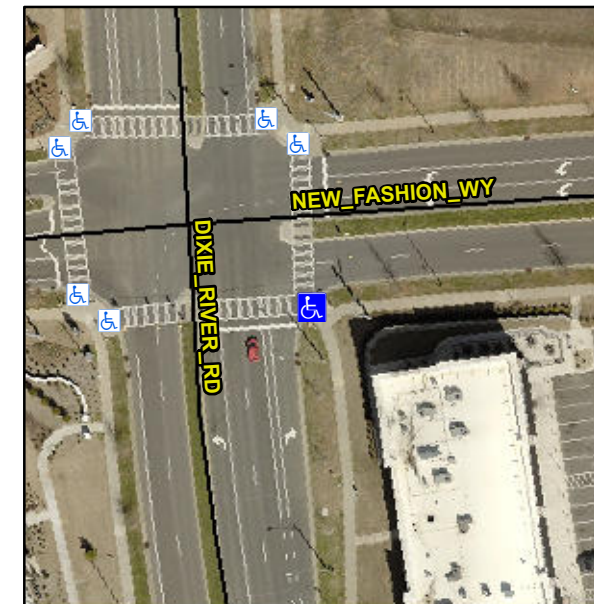
**Not Found, R304.5.1, R304.2.2, R304.5.3**

Compliance	Description	Data	Compliance	Description	Data
N/A	Ramp Length (in)	106.0	No	Ramp Slope (%)	9.1
No	Ramp Width (in)	45.0	No	Ramp XSlope (%)	2.5
N/A	Flare Type LT	N/A	N/A	Flare Type RT	N/A
N/A	Flare Slope LT (%)	N/A	N/A	Flare Slope RT (%)	N/A
N/A	Flare Traversable LT?	N/A	N/A	Flare Traversable RT?	N/A
N/A	Landing Length (in)	N/A	N/A	DWS Provided?	N/A
N/A	Landing Width (in)	N/A	N/A	DWS Contrast?	N/A
N/A	Landing Slope (%)	N/A	N/A	DWS Length (in)	N/A
N/A	Landing X Slope (%)	N/A	N/A	DWS Full Width?	N/A
N/A	Landing Curb? (Y/N)	N/A	N/A	DWS Offset (in)	N/A
N/A	Shared Landing?	N/A			
N/A	Gutter Ponding?	N/A	N/A	Gutter Slope (%)	N/A
N/A	Gutter Lip Ht (in)	N/A	N/A	Gutter X Slope (%)	N/A
N/A	Painted X Walk1?	Yes	N/A	Painted X Walk2?	Yes
	X Walk 1 Direction	To N		X Walk 2 Direction	To W
N/A	X Walk 1 Width (in)	110.0	N/A	X Walk 2 Width (in)	112.0
	X Walk 1 Slope (%)	1.4		X Walk 2 Slope (%)	0.6
	X Walk 1 X Slope (%)	0.2		X Walk 2 X Slope (%)	0.2

N/A	Ramp inside XWalk1?	Yes	N/A	Ramp inside XWalk2?	Yes
	Road Slope (%)	0.2	N/A	Clear Space?	N/A
	Road X Slope (%)	0.0	N/A	Clear Space to XWalk (in)	N/A
N/A	Any Obstructions?	N/A	N/A	Storm Grate/Utility Hazard?	N/A
	Obstruction Type			Storm Grate/Utility Type	
		N/A			N/A
		Yes		Surface Condition? (G/P)	Good

**Remove & Replace Curb Ramp With Two New Directional Ramps or Equivalent.**
