Access Compliance Report

Public Rights-of-Way

Intersection ID: 18790	Main Street: KIRKPATRICK_RD	Cross Street: RAMA_RD	Location: W
ADA ID: 0793F652760F	Ramp Type: PerpDiag	Initial Pass/Fail: Fail	Overall Compliance: No
			Severity Score: 13.75

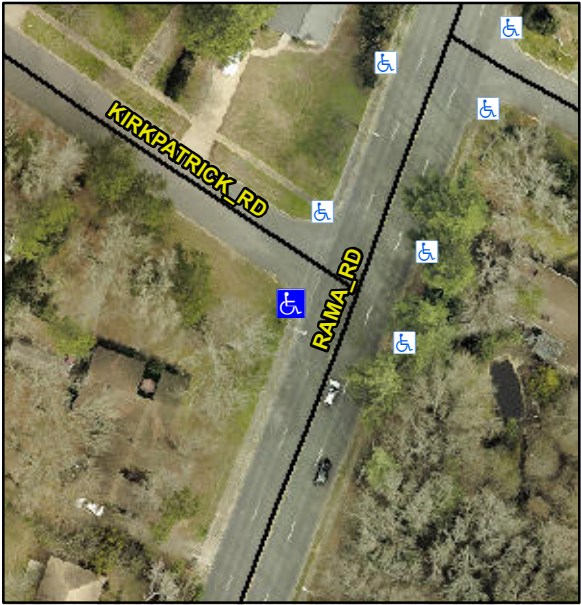
Possible Solutions:		Compliance	Description	Data
	Remove & Replace Curb Ramp With Two New Directional Ramps or Equivalent.		No	Ramp Length (in)	58.0
			Yes	Ramp Width (in)	48.0
			N/A	Flare Type LT	N/A
			N/A	Flare Slope LT (%)	N/A
			N/A	Flare Traversable LT?	N/A
			N/A	Landing Length (in)	N/A
			N/A	Landing Width (in)	N/A
			N/A	Landing Slope (%)	N/A
			N/A	Landing X Slope (%)	N/A
<p>Surveyor Notes:</p> <p>N/A</p> <p>PROW/ADA:</p> <p>Not Found, R304.2.2, R304.5.3</p>			N/A	Flare Type RT	N/A
			N/A	Flare Slope RT (%)	N/A
			N/A	Flare Traversable RT?	N/A
			N/A	DWS Provided?	N/A
			N/A	DWS Contrast?	N/A
			N/A	DWS Length (in)	N/A
			N/A	DWS Full Width?	N/A
			N/A	DWS Offset (in)	N/A
			N/A	Gutter Ponding?	N/A
			N/A	Gutter Lip Ht (in)	N/A
			No	Painted X Walk1?	No
				X Walk 1 Direction	To SE
			N/A	X Walk 1 Width (in)	N/A
				X Walk 1 Slope (%)	1.1

X Walk 1 X Slope (%)	1.3
			N/A	Ramp inside XWalk1?	N/A
			2.7	Road Slope (%)	N/A
			1.0	Road X Slope (%)	N/A
			N/A	Any Obstructions?	N/A
				Obstruction Type	
			N/A	Clear Space?	N/A
			N/A	Clear Space to XWalk (in)	N/A
			N/A	Storm Grate/Utility Hazard?	N/A
				Storm Grate/Utility Type	
			N/A		N/A
			Yes	Surface Condition? (G/P)	Good
Total Cost:		\$ 3200.00
