# Access Compliance Report

## Public Rights-of-Way (Curb Ramps)

| Intersection ID: 10018980 | Main Street: DEVONHILL_LN | Cross Street: N/A | Location: NE |
| ADA ID: 0795D22921AF | Ramp Type: PerpDiag | Initial Pass/Fail: Pass | Overall Compliance: No |

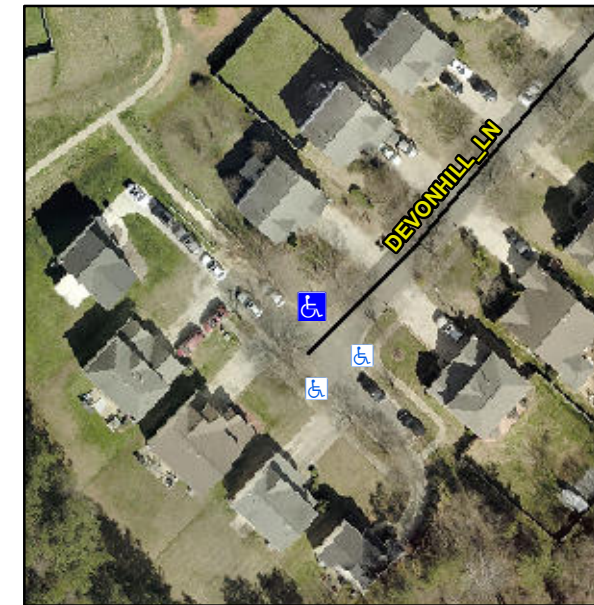
**Not Found, R304.2.1, R304.2.2-Perp, R304.3.2-Para, R305.2, R302.7, R302.7.2**

| Compliance | Description | Data | Compliance | Description | Data |
|---|---|---|---|---|---|
| No | Landing Width (in) | 43.5 | Yes | DWS Contrast? | Yes |
| No | Landing Slope (%) | 2.6 | Yes | DWS Length (in) | 24.0 |
| N/A | Landing Curb? (Y/N) | No | No | DWS Offset (in) | 8.0 |
| No | Gutter Ponding? | Yes | Yes | Gutter Slope (%) | 2.8 |
| No | Gutter Lip Ht (in) | 1.0 | Yes | Gutter X Slope (%) | 1.3 |

**Remove & Replace Curb Ramp With Two New Directional Ramps or Equivalent.**

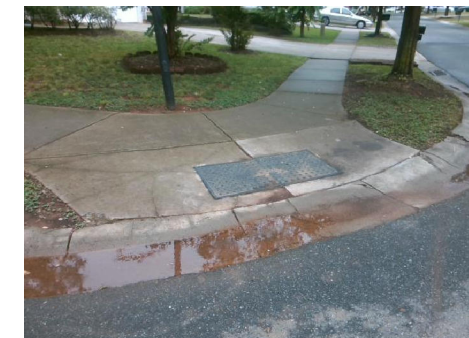
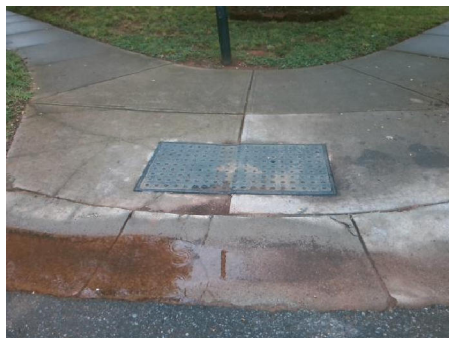
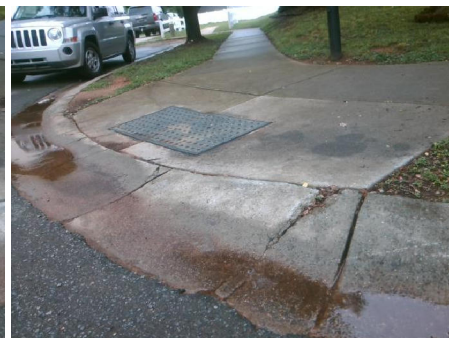
| | | Severity Score: 15 | |

Total Cost: \$ 3200.00
