Access Compliance Report

Public Rights-of-Way

(Curb Ramps)

Intersection ID: 6254	Main Street: CELANDINE_CT	Cross Street: LIATRIS_LN	Location:	W
ADA ID: 07AEEB07B5B3	Ramp Type: Perp	Initial Pass/Fail: Fail	Overall Compliance: No	Severity Score: 25
Codes/Mitigation Info/Possible Solution		Field Measurements/Component Compliance

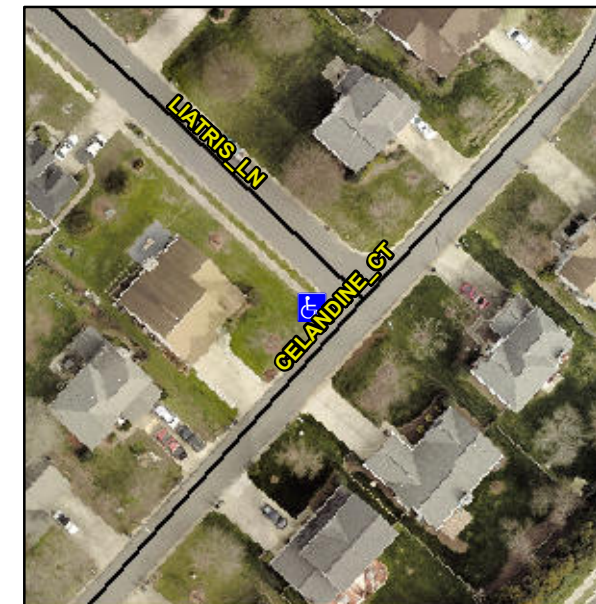
R304.2.2, R304.5.3

Compliance	Description	Data	Compliance	Description	Data
N/A	Ramp Length (in)	98.0	No	Ramp Slope (%)	8.4
Yes	Ramp Width (in)	48.0	No	Ramp XSlope (%)	6.3
N/A	Flare Type LT	N/A	N/A	Flare Type RT	N/A
N/A	Flare Slope LT (%)	N/A	N/A	Flare Slope RT (%)	N/A
N/A	Flare Traversable LT?	N/A	N/A	Flare Traversable RT?	N/A
N/A	Landing Length (in)	N/A	N/A	DWS Provided?	N/A
N/A	Landing Width (in)	N/A	N/A	DWS Contrast?	N/A
N/A	Landing Slope (%)	N/A	N/A	DWS Length (in)	N/A
N/A	Landing X Slope (%)	N/A	N/A	DWS Full Width?	N/A
N/A	Landing Curb? (Y/N)	N/A	N/A	DWS Offset (in)	N/A
N/A	Shared Landing?	N/A			
N/A	Gutter Ponding?	N/A	N/A	Gutter Slope (%)	N/A
N/A	Gutter Lip Ht (in)	N/A	N/A	Gutter X Slope (%)	N/A
N/A	Painted X Walk1?	No	N/A	Painted X Walk2?	N/A
	X Walk 1 Direction	To E		X Walk 2 Direction	N/A
N/A	X Walk 1 Width (in)	N/A	N/A	X Walk 2 Width (in)	N/A
	X Walk 1 Slope (%)	4.7		X Walk 2 Slope (%)	N/A
	X Walk 1 X Slope (%)	0.9		X Walk 2 X Slope (%)	N/A

N/A	Ramp inside XWalk1?	N/A	N/A	Ramp inside XWalk2?	N/A
	Road Slope (%)	N/A	N/A	Clear Space?	N/A
	Road X Slope (%)	N/A	N/A	Clear Space to XWalk (in)	N/A
N/A	Any Obstructions?	N/A	N/A	Storm Grate/Utility Hazard?	N/A
	Obstruction Type			Storm Grate/Utility Type	
		N/A			N/A
			Yes	Surface Condition? (G/P)	Good

Possible Solutions:

Remove & Replace Entire Ramp.

Total Cost: \$ 1850.00
