Access Compliance Report

Public Rights-of-Way

(Curb Ramps)

Intersection ID: 28377	Main Street: CORNWALLIS_HALL_DR	Cross Street: ROYAL_HIGHLANDS_CT	Location: NE
ADA ID: 07B30CBB4758	Ramp Type: BlendTrans1	Initial Pass/Fail: Fail	Overall Compliance: No
Severity Score: 1.25			
Codes/Mitigation Info/Possible Solution		Field Measurements/Component Compliance

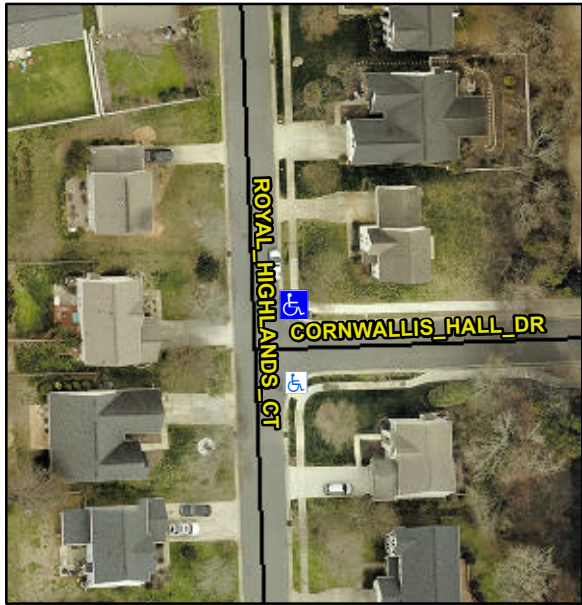
Compliance	Description	Data	Compliance	Description	Data
N/A	Ramp Length (in)	48.0	Yes	BlendTrans Slope (%)	3.6
Yes	Ramp Width (in)	50.0	No	BlendTrans XSlope (%)	2.6
N/A	Flare Type LT	N/A	N/A	Flare Type RT	N/A
N/A	Flare Slope LT (%)	N/A	N/A	Flare Slope RT (%)	N/A
N/A	Flare Traversable LT?	N/A	N/A	Flare Traversable RT?	N/A
N/A	Landing Length (in)	N/A	N/A	DWS Provided?	N/A
N/A	Landing Width (in)	N/A	N/A	DWS Contrast?	N/A
N/A	Landing Slope (%)	N/A	N/A	DWS Length (in)	N/A
N/A	Landing X Slope (%)	N/A	N/A	DWS Full Width?	N/A
N/A	Landing Curb? (Y/N)	N/A	N/A	DWS Offset (in)	N/A
N/A	Shared Landing?	N/A			
N/A	Gutter Ponding?	N/A	N/A	Gutter Slope (%)	N/A
N/A	Gutter Lip Ht (in)	N/A	N/A	Gutter X Slope (%)	N/A
N/A	Painted X Walk1?	No	N/A	Painted X Walk2?	N/A
	X Walk 1 Direction	To S		X Walk 2 Direction	N/A
	X Walk 1 Width (in)	N/A		X Walk 2 Width (in)	N/A
	X Walk 1 Slope (%)	3.5		X Walk 2 Slope (%)	N/A
	X Walk 1 X Slope (%)	3.7		X Walk 2 X Slope (%)	N/A

N/A	Ramp inside XWalk1?	N/A	N/A	Ramp inside XWalk2?	N/A
	Road Slope (%)	3.7		Clear Space?	N/A
	Road X Slope (%)	3.5	N/A	Clear Space to XWalk (in)	N/A
N/A	Any Obstructions?	N/A	N/A	Storm Grate/Utility Hazard?	N/A
	Obstruction Type			Storm Grate/Utility Type	
		N/A			N/A
			Yes	Surface Condition? (G/P)	Good
			N/A	Curb Slope (%)	1.3

Possible Solutions:						
	Remove & Replace Curb Ramp With Two New Directional Ramps or Equivalent.						
	Surveyor Notes:						
	N/A						
	PROW/ADA:						
	R304.5.3						
Street 1 Name	CORNWALLIS HALL DR						
Stop Condition-Street 1	StopSign						
Street 2 Name	N/A						
Stop Condition-Street 2	N/A						
Total Cost:		\$	3200.00

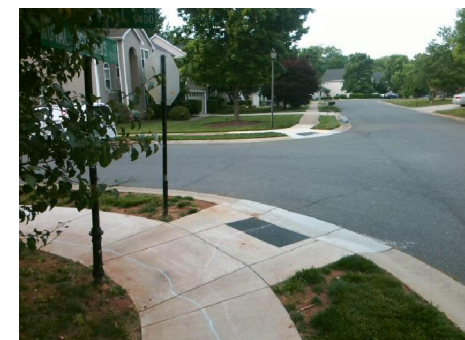
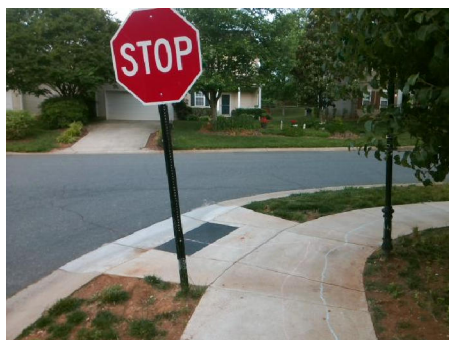
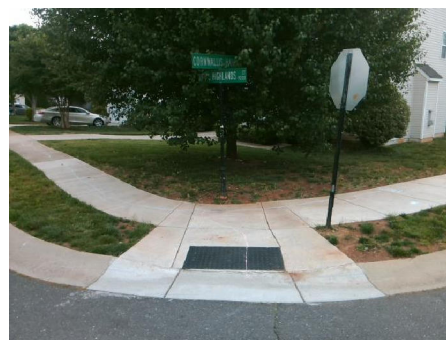
Compliance	Description	Data	Compliance	Description	Data
N/A	Ramp Length (in)	48.0	Yes	BlendTrans Slope (%)	3.6
Yes	Ramp Width (in)	50.0	No	BlendTrans XSlope (%)	2.6
N/A	Flare Type LT	N/A	N/A	Flare Type RT	N/A
N/A	Flare Slope LT (%)	N/A	N/A	Flare Slope RT (%)	N/A
N/A	Flare Traversable LT?	N/A	N/A	Flare Traversable RT?	N/A
N/A	Landing Length (in)	N/A	N/A	DWS Provided?	N/A
N/A	Landing Width (in)	N/A	N/A	DWS Contrast?	N/A
N/A	Landing Slope (%)	N/A	N/A	DWS Length (in)	N/A
N/A	Landing X Slope (%)	N/A	N/A	DWS Full Width?	N/A
N/A	Landing Curb? (Y/N)	N/A	N/A	DWS Offset (in)	N/A
N/A	Shared Landing?	N/A			
N/A	Gutter Ponding?	N/A	N/A	Gutter Slope (%)	N/A
N/A	Gutter Lip Ht (in)	N/A	N/A	Gutter X Slope (%)	N/A
N/A	Painted X Walk1?	No	N/A	Painted X Walk2?	N/A
	X Walk 1 Direction	To S		X Walk 2 Direction	N/A
	X Walk 1 Width (in)	N/A		X Walk 2 Width (in)	N/A
	X Walk 1 Slope (%)	3.5		X Walk 2 Slope (%)	N/A
	X Walk 1 X Slope (%)	3.7		X Walk 2 X Slope (%)	N/A

N/A	Ramp inside XWalk1?	N/A	N/A	Ramp inside XWalk2?	N/A
	Road Slope (%)	3.7		Clear Space?	N/A
	Road X Slope (%)	3.5	N/A	Clear Space to XWalk (in)	N/A
N/A	Any Obstructions?	N/A	N/A	Storm Grate/Utility Hazard?	N/A
	Obstruction Type			Storm Grate/Utility Type	
		N/A			N/A
			Yes	Surface Condition? (G/P)	Good
			N/A	Curb Slope (%)	1.3
