Access Compliance Report

Public Rights-of-Way

(Curb Ramps)

Intersection ID: 14547	Main Street: EAST_BV	Cross Street: SPRINGDALE_AV	Location: NE
ADA ID: 07B31187D51D	Ramp Type: Directional1	Initial Pass/Fail: Pass	Overall Compliance: No
Codes/Mitigation Info/Possible Solution		Field Measurements/Component Compliance	
Severity Score: 0

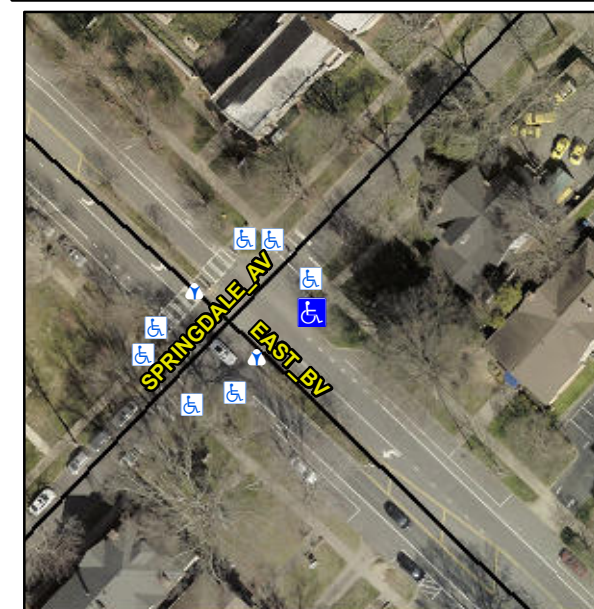
Surveyor Notes:

LNDG SLOPE NEGATIVE

PROW/ADA:

R304.2.2-Perp, R304.3.2-Para

Compliance	Description	Data	Compliance	Description	Data
N/A	Ramp Length (in)	91.0	Yes	Grade Break?	Yes
Yes	Ramp Width (in)	72.0	Yes	Grade Break Slope (%)	4.1
Yes	Ramp Slope (%)	6.6	Yes	Grade Break XSlope (%)	0.5
Yes	Ramp XSlope (%)	0.8			
Yes	Flare Type LT	N/A	Yes	Flare Type RT	N/A
N/A	Flare Slope LT (%)	N/A	N/A	Flare Slope RT (%)	N/A
N/A	Flare Traversable LT?	No	N/A	Flare Traversable RT?	No
Yes	Landing Length (in)	49.0	Yes	DWS Provided?	Yes
Yes	Landing Width (in)	72.0	Yes	DWS Contrast?	Yes
No	Landing Slope (%)	5.5	Yes	DWS Length (in)	24.0
Yes	Landing X Slope (%)	1.2	Yes	DWS Full Width?	Yes
N/A	Landing Curb? (Y/N)	N/A	Yes	DWS Offset LT (in)	0.0
N/A	Shared Landing?	No	Yes	DWS Offset RT (in)	18.0
Yes	Gutter Ponding?	No	Yes	Gutter Slope (%)	0.9
Yes	Gutter Lip Ht (in)	0.0	Yes	Gutter X Slope (%)	0.9
N/A	Painted X Walk1?	No		Road Slope (%)	3.5
	X Walk 1 Direction	To SW		Road X Slope (%)	1.5
	X Walk 1 Width (in)	N/A		Clear Space?	Yes

X Walk 1 Slope (%)	3.5	N/A	Clear Space to XWalk (in)	N/A
	X Walk 1 X Slope (%)	1.5	Yes	Storm Grate/Utility Hazard?	No
N/A	Ramp inside XWalk1?	N/A		Storm Grate/Utility Type	
Yes	Any Obstructions?	No			N/A
	Obstruction Type		Yes	Surface Condition? (G/P)	Good
			N/A	Curb Slope (%)	7.0

Possible Solutions:

Remove & Replace Landing.
