## **Access Compliance Report Public Rights-of-Way** (Curb Ramps)

Intersection ID: 28099 Main Street: DELMAHOY DR Cross Street: ROYAL PORTRUSH DR Location: SW ADA ID: 07BEC8286D3C Ramp Type: Perp Initial Pass/Fail: Pass **Overall Compliance: No** Severity Score: 15.25

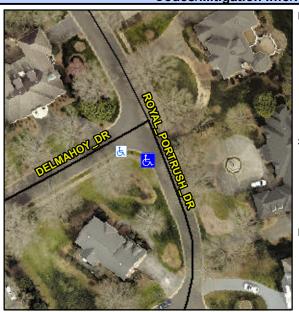
Field Measurements/Component Compliance					
Compliance Description		Data	Comp	liance Description	Data
N/A	Ramp Length (in)	94.0	Yes	Ramp Slope (%)	6.9
Yes	Ramp Width (in)	50.0	No	Ramp XSlope (%)	2.7
N/A	Flare Type LT	Sloped	N/A	Flare Type RT	N/A
N/A	Flare Slope LT (%)	8.5	Yes	Flare Slope RT (%)	1.8
N/A	Flare Traversable LT?	No	N/A	Flare Traversable RT?	Yes
No	Landing Length (in)	N/A	Yes	DWS Provided?	Yes
No	Landing Width (in)	N/A	Yes	DWS Contrast?	Yes
No	Landing Slope (%)	N/A	Yes	DWS Length (in)	24.0
No	Landing X Slope (%)	N/A	Yes	DWS Full Width?	Yes
N/A	Landing Curb? (Y/N)	No	No	DWS Offset (in)	5.0
N/A	Shared Landing?	No			
Yes	Gutter Ponding?	No	No	Gutter Slope (%)	6.2
Yes	Gutter Lip Ht (in)	0.0	No	Gutter X Slope (%)	2.3
N/A	Painted X Walk1?	No	N/A	Painted X Walk2?	N/A
	X Walk 1 Direction	То Е		X Walk 2 Direction	N/A
N/A	X Walk 1 Width (in)	N/A	N/A	X Walk 2 Width (in)	N/A
	X Walk 1 Slope (%)	2.9		X Walk 2 Slope (%)	N/A

X Walk 1 X Slope (%)	2.2		X Walk 2 X Slope (%)	N/A
N/A	Ramp inside XWalk1?	N/A	N/A	Ramp inside XWalk2?	N/A
	Road Slope (%)	N/A	N/A	Clear Space?	Yes
	Road X Slope (%)	N/A	N/A	Clear Space to XWalk (in)	N/A
Yes	Any Obstructions?	No	Yes	Storm Grate/Utility Hazard?	No
	Obstruction Type			Storm Grate/Utility Type	
		N/A			N/A
			Yes	Surface Condition? (G/P)	Good

**ROYAL PORTRUSH DR** Street 1 Name Stop Condition-Street 2 None Street 2 Name N/A Stop Condition-Street 1 N/A Possible Solutions: Remove & Replace Entire Ramp. Remove & Replace Gutter. Surveyor Notes: N/A PROW/ADA: Not Found, R304.5.3, R304.2.1, R304.2.2-Perp, R304.3.2-Para, R305.2, R304.5.4
