# Access Compliance Report

## Public Rights-of-Way

### (Curb Ramps)

| Intersection ID: 14642 | Main Street: DRESDEN_DR_WEST | Cross Street: NORLAND_RD | Location: E |

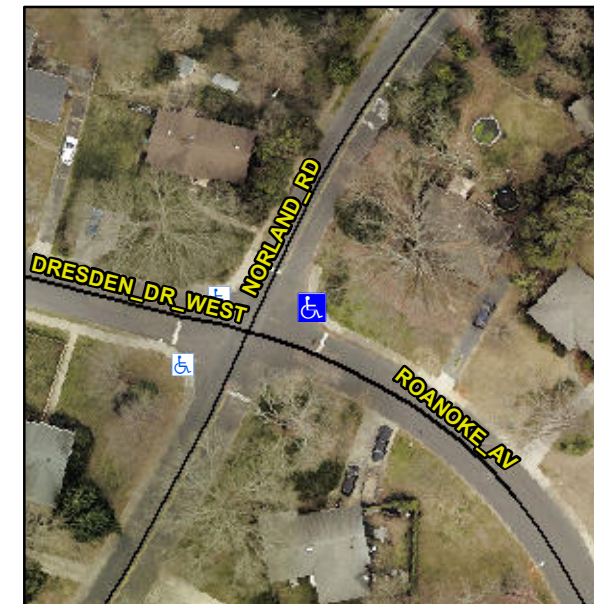
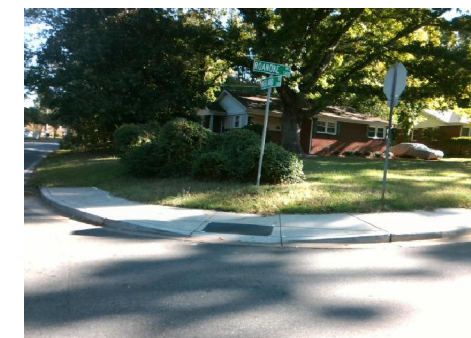
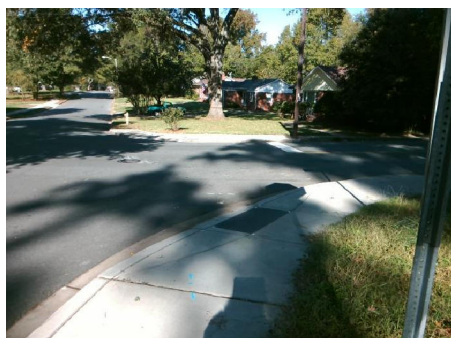
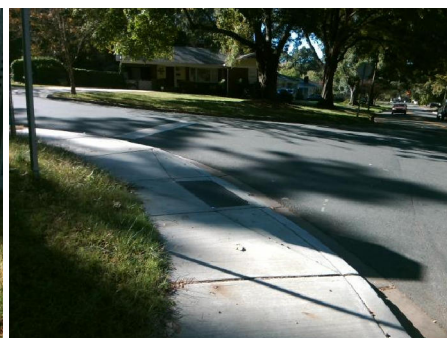
| ADA ID: 07C10D9765E8 | Ramp Type: Perp | Initial Pass/Fail: Fail | Overall Compliance: No |

**Not Found, R304.2.2, R304.5.3**

| Compliance | Description | Data | Compliance | Description | Data |
|---|---|---|---|---|---|
| N/A | Ramp Length (in) | 60.0 | No | Ramp Slope (%) | 8.4 |
| Yes | Ramp Width (in) | 52.5 | No | Ramp XSlope (%) | 3.9 |

**Remove & Replace Entire Ramp.**
