Access Compliance Report

Public Rights-of-Way

(Curb Ramps)

Intersection ID: 50603	Main Street: RHODORA_RD	Cross Street: EMPRESS_CT	Location: NE
ADA ID: 07C28DD0B6DC	Ramp Type: Perp	Initial Pass/Fail: Fail	Overall Compliance: No
		Severity Score: 35

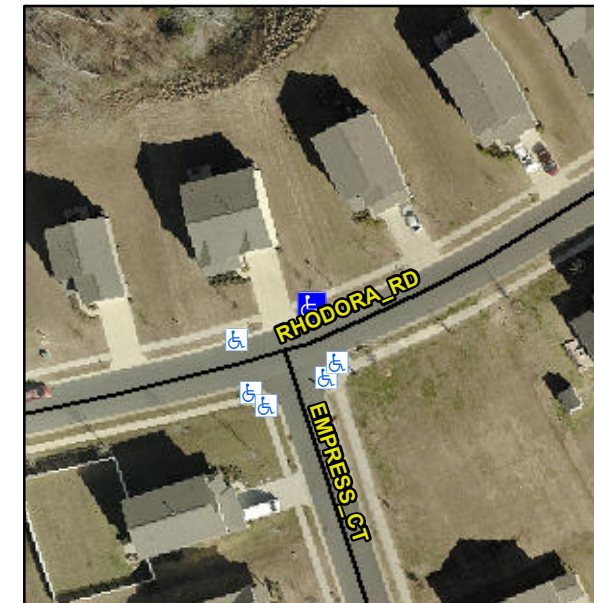
Not Found, R304.5.1, R304.2.2, R304.5.3

Compliance	Description	Data	Compliance	Description	Data
N/A	Ramp Length (in)	49.5	No	Ramp Slope (%)	14.5
No	Ramp Width (in)	47.0	No	Ramp XSlope (%)	2.4
N/A	Flare Type LT	N/A	N/A	Flare Type RT	N/A
N/A	Flare Slope LT (%)	N/A	N/A	Flare Slope RT (%)	N/A
N/A	Flare Traversable LT?	N/A	N/A	Flare Traversable RT?	N/A
N/A	Landing Length (in)	N/A	N/A	DWS Provided?	N/A
N/A	Landing Width (in)	N/A	N/A	DWS Contrast?	N/A
N/A	Landing Slope (%)	N/A	N/A	DWS Length (in)	N/A
N/A	Landing X Slope (%)	N/A	N/A	DWS Full Width?	N/A
N/A	Landing Curb? (Y/N)	N/A	N/A	DWS Offset (in)	N/A
N/A	Shared Landing?	N/A			
N/A	Gutter Ponding?	N/A	N/A	Gutter Slope (%)	N/A
N/A	Gutter Lip Ht (in)	N/A	N/A	Gutter X Slope (%)	N/A
N/A	Painted X Walk1?	No	N/A	Painted X Walk2?	N/A
	X Walk 1 Direction	To S		X Walk 2 Direction	N/A
N/A	X Walk 1 Width (in)	N/A	N/A	X Walk 2 Width (in)	N/A
	X Walk 1 Slope (%)	3.1		X Walk 2 Slope (%)	N/A
	X Walk 1 X Slope (%)	2.1		X Walk 2 X Slope (%)	N/A

Remove & Replace Entire Ramp.

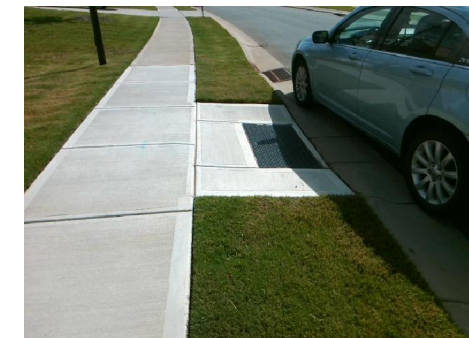
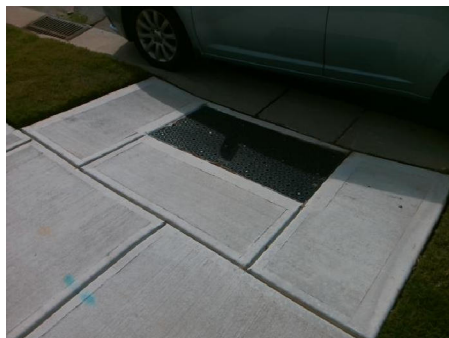
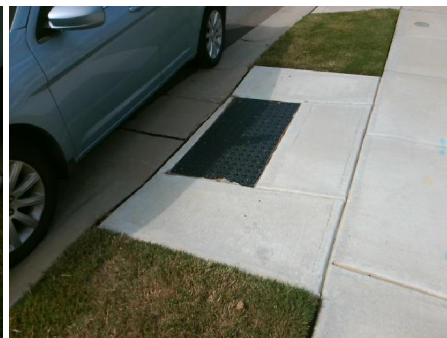
N/A	Ramp inside XWalk1?	N/A	N/A	Ramp inside XWalk2?	N/A
	Road Slope (%)	N/A	N/A	Clear Space?	N/A
	Road X Slope (%)	N/A	N/A	Clear Space to XWalk (in)	N/A
N/A	Any Obstructions?	N/A	N/A	Storm Grate/Utility Hazard?	N/A
	Obstruction Type			Storm Grate/Utility Type	
		N/A			N/A
			Yes	Surface Condition? (G/P)	Good
