# Access Compliance Report

## Public Rights-of-Way

### (Curb Ramps)

Intersection ID: 17306	Main Street: ELECTRA_LN	Cross Street: BUICK_DR	Location: S
ADA ID: 07C694F586D7	Ramp Type: PerpDiag	Initial Pass/Fail: Fail	Overall Compliance: No
Severity Score: 12.5			
Codes/Mitigation Info/Possible Solution		Field Measurements/Component Compliance

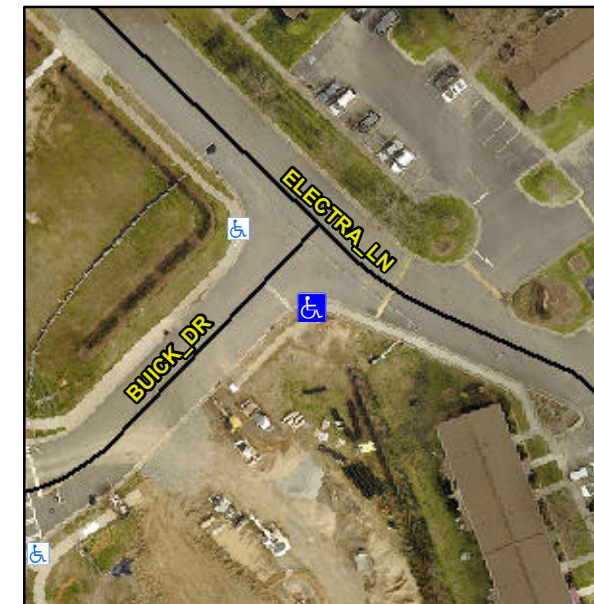
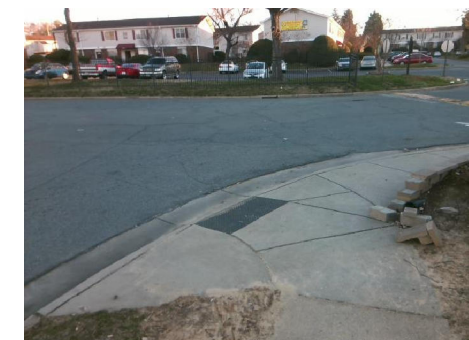
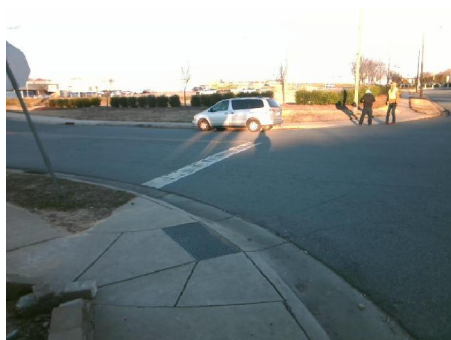
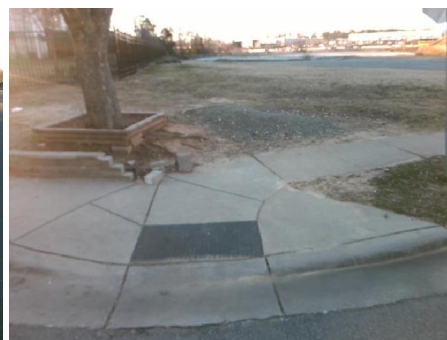
Compliance	Description	Data	Compliance	Description	Data
N/A	Ramp Length (in)	42.0	No	Ramp Slope (%)	9.5
Yes	Ramp Width (in)	48.0	Yes	Ramp XSlope (%)	0.2
N/A	Flare Type LT	N/A	N/A	Flare Type RT	N/A
N/A	Flare Slope LT (%)	N/A	N/A	Flare Slope RT (%)	N/A
N/A	Flare Traversable LT?	N/A	N/A	Flare Traversable RT?	N/A
N/A	Landing Length (in)	N/A	N/A	DWS Provided?	N/A
N/A	Landing Width (in)	N/A	N/A	DWS Contrast?	N/A
N/A	Landing Slope (%)	N/A	N/A	DWS Length (in)	N/A
N/A	Landing X Slope (%)	N/A	N/A	DWS Full Width?	N/A
N/A	Landing Curb? (Y/N)	N/A	N/A	DWS Offset (in)	N/A
N/A	Shared Landing?	N/A			
N/A	Gutter Ponding?	N/A	N/A	Gutter Slope (%)	N/A
N/A	Gutter Lip Ht (in)	N/A	N/A	Gutter X Slope (%)	N/A
N/A	Painted X Walk1?	No	N/A	Painted X Walk2?	No
	X Walk 1 Direction	To NE		X Walk 2 Direction	To NW
N/A	X Walk 1 Width (in)	N/A	N/A	X Walk 2 Width (in)	N/A
	X Walk 1 Slope (%)	5.2		X Walk 2 Slope (%)	3.0
	X Walk 1 X Slope (%)	0.2		X Walk 2 X Slope (%)	3.1

N/A	Ramp inside XWalk1?	N/A	N/A	Ramp inside XWalk2?	N/A
	Road Slope (%)	0.8	N/A	Clear Space?	N/A
	Road X Slope (%)	5.4	N/A	Clear Space to XWalk (in)	N/A
N/A	Any Obstructions?	N/A	N/A	Storm Grate/Utility Hazard?	N/A
	Obstruction Type			Storm Grate/Utility Type	
		N/A			N/A
			Yes	Surface Condition? (G/P)	Good

Possible Solutions:

**Remove & Replace Curb Ramp With Two New Directional Ramps or Equivalent.**
