# Access Compliance Report

## Public Rights-of-Way

### (Curb Ramps)

Intersection ID: 3031	Main Street: AMBER_GLEN_DR	Cross Street: AZURE_VALLEY_PL	Location: E
ADA ID: 07C72CE7A569	Ramp Type: Perp	Initial Pass/Fail: Fail	Overall Compliance: No
Codes/Mitigation Info/Possible Solution		Field Measurements/Component Compliance	
		Severity Score: 10

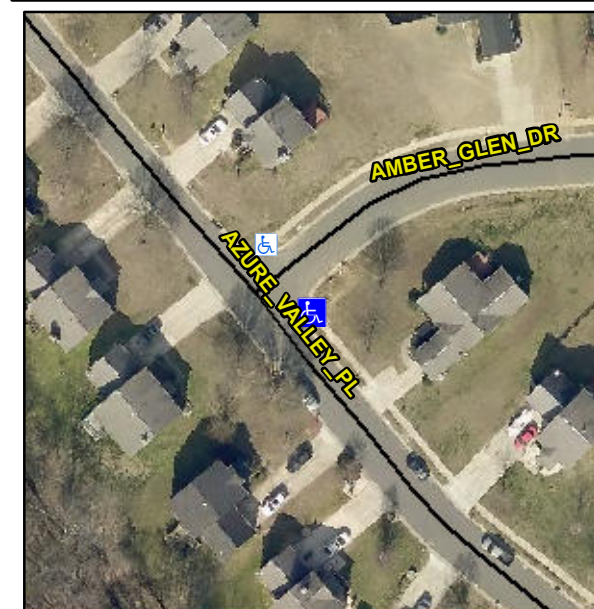
**Not Found, R304.5.1, R304.5.3**

Compliance	Description	Data	Compliance	Description	Data
N/A	Ramp Length (in)	47.0	Yes	Ramp Slope (%)	5.0
No	Ramp Width (in)	47.0	No	Ramp XSlope (%)	2.9
N/A	Flare Type LT	N/A	N/A	Flare Type RT	N/A
N/A	Flare Slope LT (%)	N/A	N/A	Flare Slope RT (%)	N/A
N/A	Flare Traversable LT?	N/A	N/A	Flare Traversable RT?	N/A
N/A	Landing Length (in)	N/A	N/A	DWS Provided?	N/A
N/A	Landing Width (in)	N/A	N/A	DWS Contrast?	N/A
N/A	Landing Slope (%)	N/A	N/A	DWS Length (in)	N/A
N/A	Landing X Slope (%)	N/A	N/A	DWS Full Width?	N/A
N/A	Landing Curb? (Y/N)	N/A	N/A	DWS Offset (in)	N/A
N/A	Shared Landing?	N/A			
N/A	Gutter Ponding?	N/A	N/A	Gutter Slope (%)	N/A
N/A	Gutter Lip Ht (in)	N/A	N/A	Gutter X Slope (%)	N/A
N/A	Painted X Walk1?	No	N/A	Painted X Walk2?	N/A
	X Walk 1 Direction	To NW		X Walk 2 Direction	N/A
N/A	X Walk 1 Width (in)	N/A	N/A	X Walk 2 Width (in)	N/A
	X Walk 1 Slope (%)	4.9		X Walk 2 Slope (%)	N/A
	X Walk 1 X Slope (%)	1.2		X Walk 2 X Slope (%)	N/A

N/A	Ramp inside XWalk1?	N/A	N/A	Ramp inside XWalk2?	N/A
	Road Slope (%)	N/A	N/A	Clear Space?	N/A
	Road X Slope (%)	N/A	N/A	Clear Space to XWalk (in)	N/A
N/A	Any Obstructions?	N/A	N/A	Storm Grate/Utility Hazard?	N/A
	Obstruction Type			Storm Grate/Utility Type	
		N/A			N/A
			Yes	Surface Condition? (G/P)	Good

Possible Solutions:

**Remove & Replace Entire Ramp.**
