# Access Compliance Report

## Public Rights-of-Way

Intersection ID: 32129	Main Street: BELLWOOD_LN	Cross Street: PROVIDENCE_RD	Location:	N
ADA ID: 07CD73235BD0	Ramp Type: Perp	Initial Pass/Fail: Fail	Overall Compliance: No	Severity Score: 22.5
Codes/Mitigation Info/Possible Solution		Field Measurements/Component Compliance

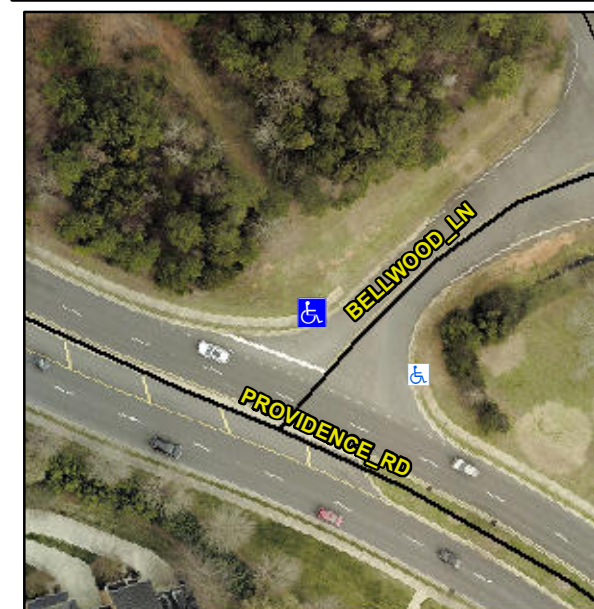
Compliance	Description	Data	Compliance	Description	Data
N/A	Ramp Length (in)	84.0	No	Ramp Slope (%)	9.0
No	Ramp Width (in)	46.0	No	Ramp XSlope (%)	2.8
N/A	Flare Type LT	N/A	N/A	Flare Type RT	N/A
N/A	Flare Slope LT (%)	N/A	N/A	Flare Slope RT (%)	N/A
N/A	Flare Traversable LT?	N/A	N/A	Flare Traversable RT?	N/A
N/A	Landing Length (in)	N/A	N/A	DWS Provided?	N/A
N/A	Landing Width (in)	N/A	N/A	DWS Contrast?	N/A
N/A	Landing Slope (%)	N/A	N/A	DWS Length (in)	N/A
N/A	Landing X Slope (%)	N/A	N/A	DWS Full Width?	N/A
N/A	Landing Curb? (Y/N)	N/A	N/A	DWS Offset (in)	N/A
N/A	Shared Landing?	N/A			
N/A	Gutter Ponding?	N/A	N/A	Gutter Slope (%)	N/A
N/A	Gutter Lip Ht (in)	N/A	N/A	Gutter X Slope (%)	N/A
N/A	Painted X Walk1?	No	N/A	Painted X Walk2?	N/A
	X Walk 1 Direction	To SE		X Walk 2 Direction	N/A
N/A	X Walk 1 Width (in)	N/A	N/A	X Walk 2 Width (in)	N/A
	X Walk 1 Slope (%)	3.3		X Walk 2 Slope (%)	N/A
	X Walk 1 X Slope (%)	0.4		X Walk 2 X Slope (%)	N/A

N/A	Ramp inside XWalk1?	N/A	N/A	Ramp inside XWalk2?	N/A
	Road Slope (%)	N/A	N/A	Clear Space?	N/A
	Road X Slope (%)	N/A	N/A	Clear Space to XWalk (in)	N/A
N/A	Any Obstructions?	N/A	N/A	Storm Grate/Utility Hazard?	N/A
	Obstruction Type			Storm Grate/Utility Type	
		N/A			N/A
			Yes	Surface Condition? (G/P)	Good

**Remove & Replace Entire Ramp.**

**R304.5.1, R304.2.2, R304.5.3**

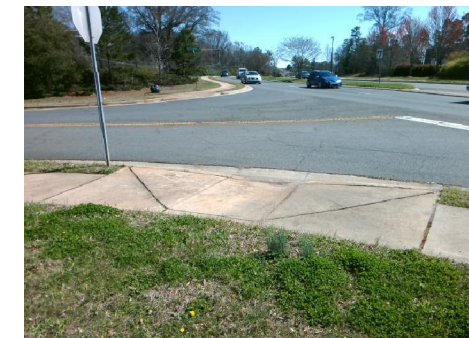
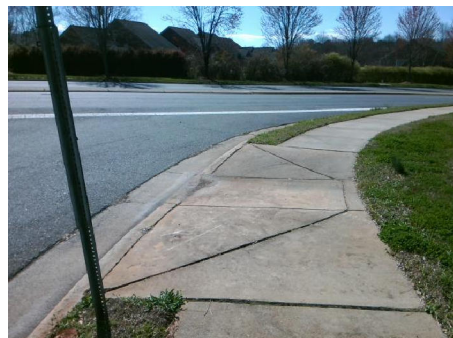
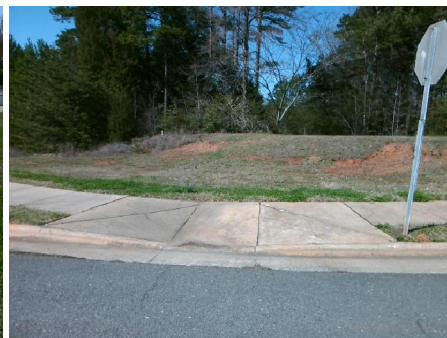
Street 1 Name **BELLWOOD LN**  
 Stop Condition-Street 2 **StopSign**  
 Street 2 Name **N/A**  
 Stop Condition-Street 1 **N/A**
