Access Compliance Report

Public Rights-of-Way

(Curb Ramps)

Intersection ID: 50617	Main Street: GOLDEN_WOOD_LN	Cross Street: PADDLE_OAK_RD	Location: NE
ADA ID: 07CE0D2930A7	Ramp Type: Perp	Initial Pass/Fail: Fail	Overall Compliance: No
Severity Score: 22.5			
Codes/Mitigation Info/Possible Solution		Field Measurements/Component Compliance

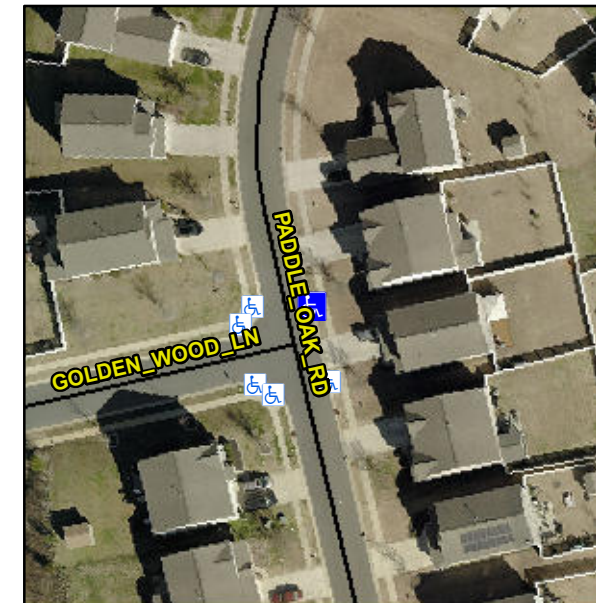
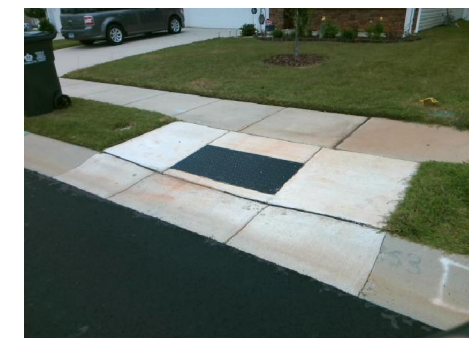
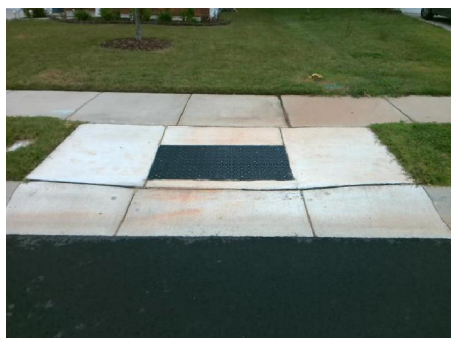
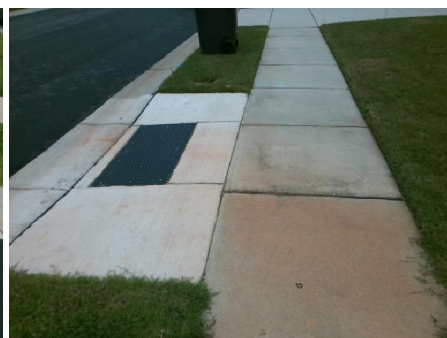
Not Found, R304.5.1, R304.2.2

Compliance	Description	Data	Compliance	Description	Data
N/A	Ramp Length (in)	46.0	No	Ramp Slope (%)	10.9
No	Ramp Width (in)	47.5	Yes	Ramp XSlope (%)	2.8
N/A	Flare Type LT	N/A	N/A	Flare Type RT	N/A
N/A	Flare Slope LT (%)	N/A	N/A	Flare Slope RT (%)	N/A
N/A	Flare Traversable LT?	N/A	N/A	Flare Traversable RT?	N/A
N/A	Landing Length (in)	N/A	N/A	DWS Provided?	N/A
N/A	Landing Width (in)	N/A	N/A	DWS Contrast?	N/A
N/A	Landing Slope (%)	N/A	N/A	DWS Length (in)	N/A
N/A	Landing X Slope (%)	N/A	N/A	DWS Full Width?	N/A
N/A	Landing Curb? (Y/N)	N/A	N/A	DWS Offset (in)	N/A
N/A	Shared Landing?	N/A			
N/A	Gutter Ponding?	N/A	N/A	Gutter Slope (%)	N/A
N/A	Gutter Lip Ht (in)	N/A	N/A	Gutter X Slope (%)	N/A
N/A	Painted X Walk1?	No	N/A	Painted X Walk2?	N/A
	X Walk 1 Direction	To W		X Walk 2 Direction	N/A
N/A	X Walk 1 Width (in)	N/A	N/A	X Walk 2 Width (in)	N/A
	X Walk 1 Slope (%)	0.9		X Walk 2 Slope (%)	N/A
	X Walk 1 X Slope (%)	2.8		X Walk 2 X Slope (%)	N/A

N/A	Ramp inside XWalk1?	N/A	N/A	Ramp inside XWalk2?	N/A
	Road Slope (%)	N/A	N/A	Clear Space?	N/A
	Road X Slope (%)	N/A	N/A	Clear Space to XWalk (in)	N/A
N/A	Any Obstructions?	N/A	N/A	Storm Grate/Utility Hazard?	N/A
	Obstruction Type			Storm Grate/Utility Type	
		N/A			N/A
			Yes	Surface Condition? (G/P)	Good

Remove & Replace Entire Ramp.
