Access Compliance Report

Public Rights-of-Way

(Curb Ramps)

Intersection ID: 15116	Main Street: EUCLID_AV	Cross Street: IDEAL_WY	Location: E
ADA ID: 07D09C833FAB	Ramp Type: Perp	Initial Pass/Fail: Fail	Overall Compliance: No
			Severity Score: 13.75

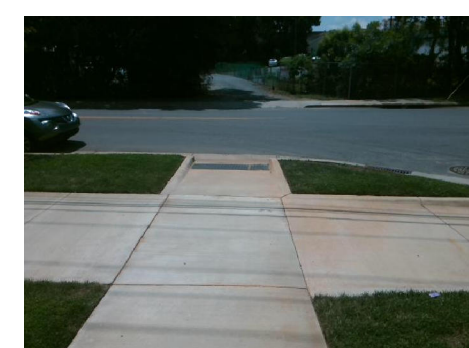
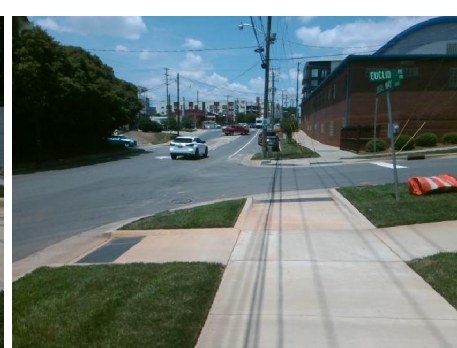
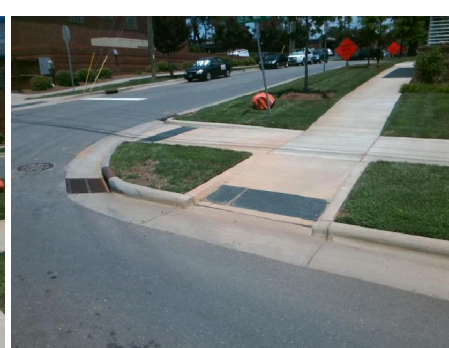
Possible Solutions:		Compliance	Description	Data
	Remove & Replace Entire Ramp.		N/A	Ramp Length (in)	98.0
			Yes	Ramp Width (in)	65.0
			N/A	Flare Type LT	N/A
			N/A	Flare Slope LT (%)	N/A
			N/A	Flare Traversable LT?	N/A
			N/A	Landing Length (in)	N/A
			N/A	Landing Width (in)	N/A
			N/A	Landing Slope (%)	N/A
			N/A	Landing X Slope (%)	N/A
<p>Surveyor Notes:</p> <p>N/A</p> <p>PROW/ADA:</p> <p>R304.2.2, R304.5.3</p>			N/A	Flare Type RT	N/A
			N/A	Flare Slope RT (%)	N/A
			N/A	Flare Traversable RT?	N/A
			N/A	DWS Provided?	N/A
			N/A	DWS Contrast?	N/A
			N/A	DWS Length (in)	N/A
			N/A	DWS Full Width?	N/A
			N/A	DWS Offset (in)	N/A
			N/A	Shared Landing?	N/A
			N/A	Gutter Ponding?	N/A
			N/A	Gutter Lip Ht (in)	N/A
			N/A	Painted X Walk1?	No
				X Walk 1 Direction	To SW
			N/A	X Walk 1 Width (in)	N/A
				X Walk 1 Slope (%)	2.9
				X Walk 1 X Slope (%)	1.8

N/A	Ramp inside XWalk1?	N/A
				Road Slope (%)	N/A
				Road X Slope (%)	N/A
			N/A	Any Obstructions?	N/A
				Obstruction Type	
Total Cost:		\$ 1850.00			
			N/A		N/A
			Yes	Surface Condition? (G/P)	Good
