Access Compliance Report

Public Rights-of-Way

(Curb Ramps)

Intersection ID: 54461	Main Street: FENWAY_DR	Cross Street: FLINT_HILL_DR	Location: NE
ADA ID: 07E1F2EEE1F0	Ramp Type: Perp	Initial Pass/Fail: Pass	Overall Compliance: No
		Severity Score: 15

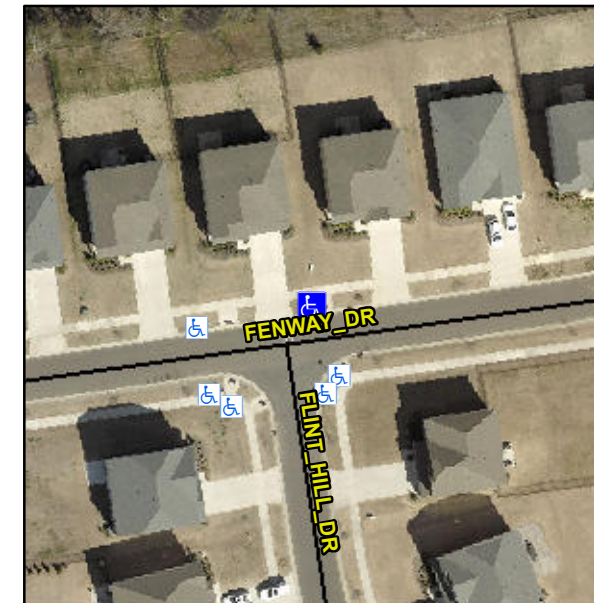
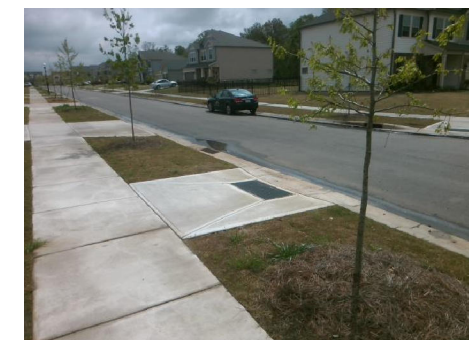
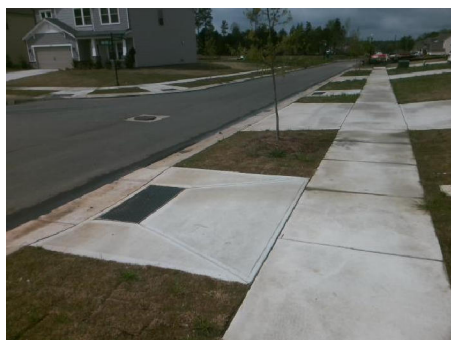
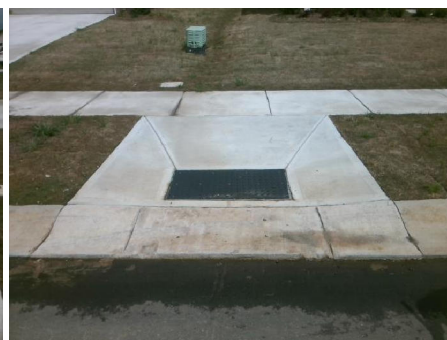
Compliance	Description	Data	Compliance	Description	Data
N/A	Ramp Length (in)	95.0	Yes	Ramp Slope (%)	6.5
Yes	Ramp Width (in)	48.0	Yes	Ramp XSlope (%)	1.7
N/A	Flare Type LT	Sloped	N/A	Flare Type RT	N/A
N/A	Flare Slope LT (%)	6.3	Yes	Flare Slope RT (%)	8.6
N/A	Flare Traversable LT?	Yes	N/A	Flare Traversable RT?	Yes
Yes	Landing Length (in)	58.0	Yes	DWS Provided?	Yes
Yes	Landing Width (in)	48.0	Yes	DWS Contrast?	Yes
No	Landing Slope (%)	2.1	Yes	DWS Length (in)	24.0
Yes	Landing X Slope (%)	0.5	Yes	DWS Full Width?	Yes
N/A	Landing Curb? (Y/N)	No	No	DWS Offset (in)	4.0
N/A	Shared Landing?	No			
Yes	Gutter Ponding?	No	Yes	Gutter Slope (%)	1.3
No	Gutter Lip Ht (in)	1.5	Yes	Gutter X Slope (%)	0.0
N/A	Painted X Walk1?	No	N/A	Painted X Walk2?	N/A
	X Walk 1 Direction	To S		X Walk 2 Direction	N/A
N/A	X Walk 1 Width (in)	N/A	N/A	X Walk 2 Width (in)	N/A
	X Walk 1 Slope (%)	2.6		X Walk 2 Slope (%)	N/A
	X Walk 1 X Slope (%)	0.2		X Walk 2 X Slope (%)	N/A

N/A	Ramp inside XWalk1?	N/A	N/A	Ramp inside XWalk2?	N/A
	Road Slope (%)	N/A	N/A	Clear Space?	Yes
	Road X Slope (%)	N/A	N/A	Clear Space to XWalk (in)	N/A
Yes	Any Obstructions?	No	Yes	Storm Grate/Utility Hazard?	No
	Obstruction Type			Storm Grate/Utility Type	
		N/A			N/A
			Yes	Surface Condition? (G/P)	Good

**Remove & Replace Entire Ramp.
Grind Gutter Lip.**
