Access Compliance Report

Public Rights-of-Way

(Curb Ramps)

Intersection ID: 11521	Main Street: W_11TH_ST	Cross Street: N_CHURCH_ST	Location: W
ADA ID: 07E98B428DD2	Ramp Type: BlendTrans1	Initial Pass/Fail: Fail	Overall Compliance: No
Severity Score: 12.5			
Codes/Mitigation Info/Possible Solution		Field Measurements/Component Compliance

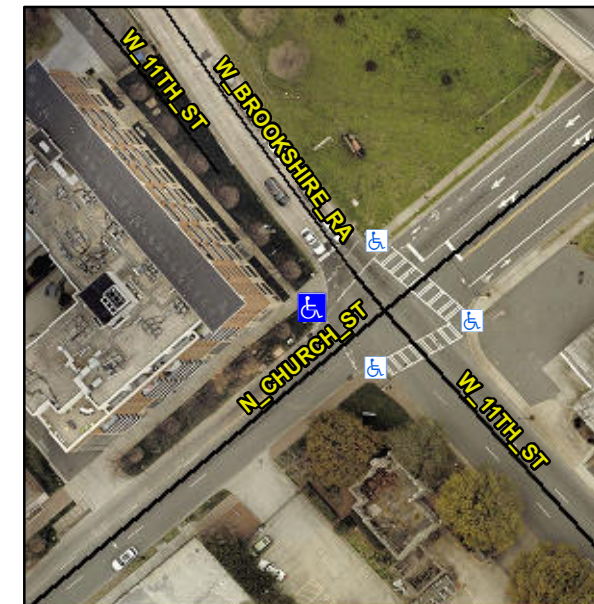
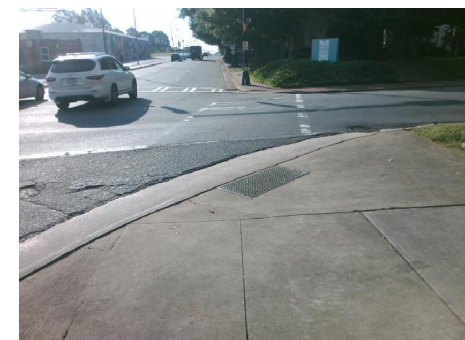
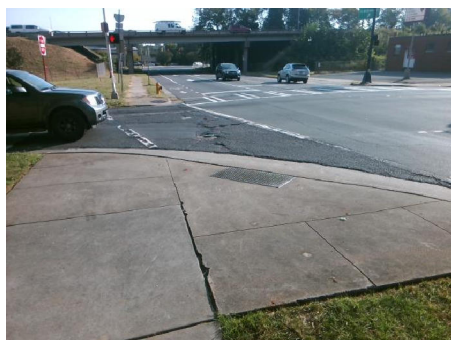
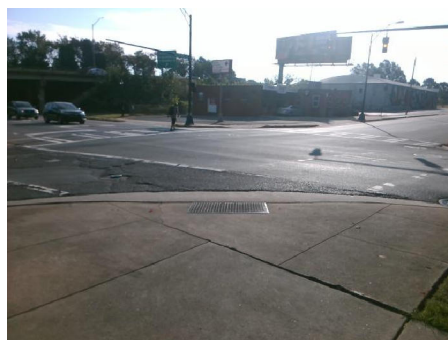
Compliance	Description	Data	Compliance	Description	Data
N/A	Ramp Length (in)	66.0	Yes	BlendTrans Slope (%)	5.0
Yes	Ramp Width (in)	70.0	No	BlendTrans XSlope (%)	5.7
N/A	Flare Type LT	N/A	N/A	Flare Type RT	N/A
N/A	Flare Slope LT (%)	N/A	N/A	Flare Slope RT (%)	N/A
N/A	Flare Traversable LT?	N/A	N/A	Flare Traversable RT?	N/A
N/A	Landing Length (in)	N/A	N/A	DWS Provided?	N/A
N/A	Landing Width (in)	N/A	N/A	DWS Contrast?	N/A
N/A	Landing Slope (%)	N/A	N/A	DWS Length (in)	N/A
N/A	Landing X Slope (%)	N/A	N/A	DWS Full Width?	N/A
N/A	Landing Curb? (Y/N)	N/A	N/A	DWS Offset (in)	N/A
N/A	Shared Landing?	N/A			
N/A	Gutter Ponding?	N/A	N/A	Gutter Slope (%)	N/A
N/A	Gutter Lip Ht (in)	N/A	N/A	Gutter X Slope (%)	N/A
N/A	Painted X Walk1?	Yes	N/A	Painted X Walk2?	Yes
	X Walk 1 Direction	To SE		X Walk 2 Direction	To NE
	X Walk 1 Width (in)	114.0		X Walk 2 Width (in)	111.0
	X Walk 1 Slope (%)	5.5		X Walk 2 Slope (%)	1.0
	X Walk 1 X Slope (%)	0.6		X Walk 2 X Slope (%)	4.9

N/A	Ramp inside XWalk1?	Yes	N/A	Ramp inside XWalk2?	Yes
	Road Slope (%)	2.8		Clear Space?	N/A
	Road X Slope (%)	5.2	N/A	Clear Space to XWalk (in)	N/A
N/A	Any Obstructions?	N/A	N/A	Storm Grate/Utility Hazard?	N/A
	Obstruction Type			Storm Grate/Utility Type	
		N/A			N/A
		Yes		Surface Condition? (G/P)	Good
		N/A		Curb Slope (%)	0.2

Possible Solutions:

Remove & Replace Curb Ramp With Two New Directional Ramps or Equivalent.

R304.5.3
