# Access Compliance Report

## Public Rights-of-Way

### (Curb Ramps)

| Intersection ID: 11833 | Main Street: MATHESON_AV | Cross Street: STONEYBROOK_RD | Location: NE |

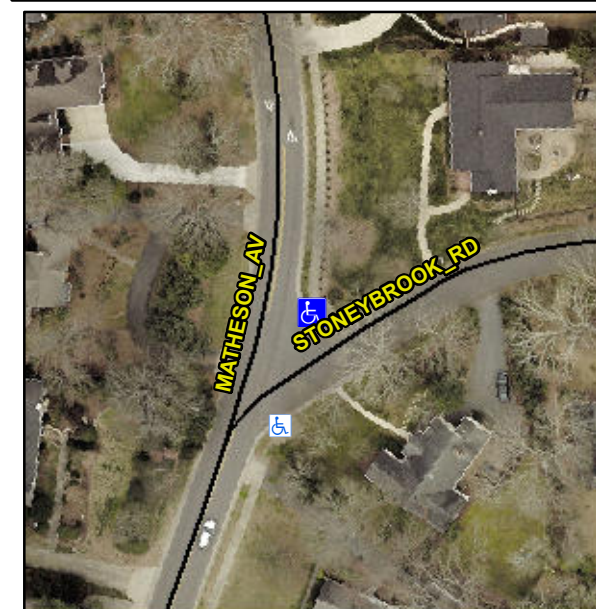
| ADA ID: 07EDF0E8EE06 | Ramp Type: Perp | Initial Pass/Fail: Fail | Overall Compliance: No |

**Not Found, R304.5.1, R304.5.3**

| Compliance | Description | Data | Compliance | Description | Data |
|---|---|---|---|---|---|
| N/A | Ramp Length (in) | 47.0 | Yes | Ramp Slope (%) | 6.3 |
| No | Ramp Width (in) | 44.0 | No | Ramp XSlope (%) | 8.7 |

**Remove & Replace Entire Ramp.**

Total Cost: \$ 1850.00
