## Access Compliance Report Public Rights-of-Way (Curb Ramps)

Intersection ID: N/AMain Street:STEEL\_CREEK\_RDCross Street:ENTRANCE\_DRLocation:WADA ID: 07F8754C6D37Ramp Type:PerpDiagInitial Pass/Fail:FailOverall Compliance:NoSeverity Score:10

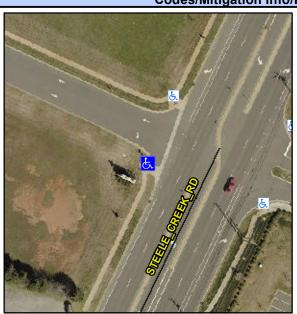
Field Measurements/Component Compliance					
Compliance Description		Data	Comp	liance Description	Data
N/	A Ramp Length (in)	96.0	Yes	Ramp Slope (%)	8.0
No	Ramp Width (in)	47.0	No	Ramp XSlope (%)	2.9
N/	A Flare Type LT	N/A	N/A	Flare Type RT	N/A
N/	A Flare Slope LT (%)	N/A	N/A	Flare Slope RT (%)	N/A
N/	A Flare Traversable LT?	N/A	N/A	Flare Traversable RT?	N/A
N/	A Landing Length (in)	N/A	N/A	DWS Provided?	N/A
N/	A Landing Width (in)	N/A	N/A	DWS Contrast?	N/A
N/	A Landing Slope (%)	N/A	N/A	DWS Length (in)	N/A
N/	A Landing X Slope (%)	N/A	N/A	DWS Full Width?	N/A
N/	A Landing Curb? (Y/N)	N/A	N/A	DWS Offset (in)	N/A
N/	A Shared Landing?	N/A			
N/	A Gutter Ponding?	N/A	N/A	Gutter Slope (%)	N/A
N/	A Gutter Lip Ht (in)	N/A	N/A	Gutter X Slope (%)	N/A
N/	A Painted X Walk1?	No	N/A	Painted X Walk2?	No
	X Walk 1 Direction	To E		X Walk 2 Direction	To N
N/	A X Walk 1 Width (in)	N/A	N/A	X Walk 2 Width (in)	N/A
	X Walk 1 Slope (%)	2.3		X Walk 2 Slope (%)	2.0

X Walk 1 X Slope (%)	0.0		X Walk 2 X Slope (%)	1.0
N/	A Ramp inside XWalk1?	N/A	N/A	Ramp inside XWalk2?	N/A
	Road Slope (%)	3.4	N/A	Clear Space?	N/A
	Road X Slope (%)	0.5	N/A	Clear Space to XWalk (in)	N/A
N/	A Any Obstructions?	N/A	N/A	Storm Grate/Utility Hazard?	N/A
	Obstruction Type			Storm Grate/Utility Type	
		N/A			N/A
			Yes	Surface Condition? (G/P)	Good

STEELE CREEK RD None ENTRANCE DR StopSign Possible Solutions:

Remove & Replace Curb Ramp With Two New Directional Ramps or Equivalent.

R304.5.1, R304.5.3
