Access Compliance Report

Public Rights-of-Way

(Curb Ramps)

Intersection ID: 10957	Main Street: CRISMAN_ST	Cross Street: PACIFIC_ST	Location: E
ADA ID: 080032874D11	Ramp Type: BlendTrans1	Initial Pass/Fail: Fail	Overall Compliance: No
Severity Score: 1.25			
Codes/Mitigation Info/Possible Solution		Field Measurements/Component Compliance

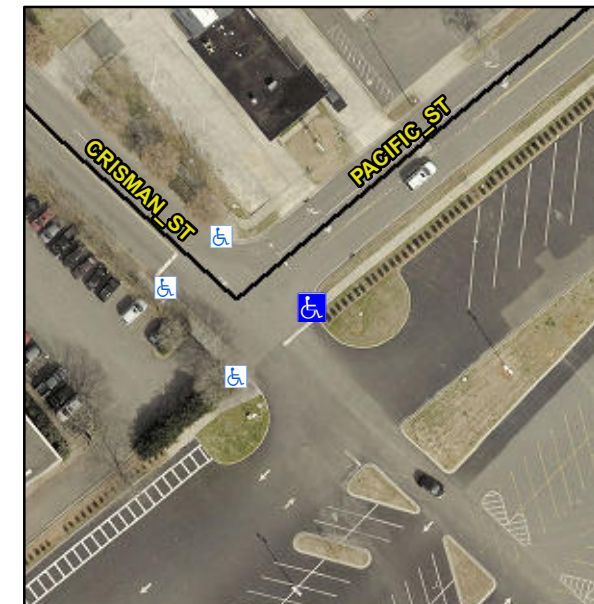
Not Found, R304.5.3

Compliance	Description	Data	Compliance	Description	Data
N/A	Ramp Length (in)	51.0	Yes	BlendTrans Slope (%)	2.3
Yes	Ramp Width (in)	73.0	No	BlendTrans XSlope (%)	2.8
N/A	Flare Type LT	N/A	N/A	Flare Type RT	N/A
N/A	Flare Slope LT (%)	N/A	N/A	Flare Slope RT (%)	N/A
N/A	Flare Traversable LT?	N/A	N/A	Flare Traversable RT?	N/A
N/A	Landing Length (in)	N/A	N/A	DWS Provided?	N/A
N/A	Landing Width (in)	N/A	N/A	DWS Contrast?	N/A
N/A	Landing Slope (%)	N/A	N/A	DWS Length (in)	N/A
N/A	Landing X Slope (%)	N/A	N/A	DWS Full Width?	N/A
N/A	Landing Curb? (Y/N)	N/A	N/A	DWS Offset (in)	N/A
N/A	Shared Landing?	N/A			
N/A	Gutter Ponding?	N/A	N/A	Gutter Slope (%)	N/A
N/A	Gutter Lip Ht (in)	N/A	N/A	Gutter X Slope (%)	N/A
N/A	Painted X Walk1?	No	N/A	Painted X Walk2?	No
	X Walk 1 Direction	To NW		X Walk 2 Direction	To SW
	X Walk 1 Width (in)	N/A		X Walk 2 Width (in)	N/A
	X Walk 1 Slope (%)	4.7		X Walk 2 Slope (%)	1.8
	X Walk 1 X Slope (%)	2.8		X Walk 2 X Slope (%)	5.0

N/A	Ramp inside XWalk1?	N/A	N/A	Ramp inside XWalk2?	N/A
	Road Slope (%)	0.9		Clear Space?	N/A
	Road X Slope (%)	4.2	N/A	Clear Space to XWalk (in)	N/A
N/A	Any Obstructions?	N/A	N/A	Storm Grate/Utility Hazard?	N/A
	Obstruction Type			Storm Grate/Utility Type	
		N/A			N/A
		Yes		Surface Condition? (G/P)	Good
		No		Curb Slope (%)	7.7

Possible Solutions:

Remove & Replace Curb Ramp With Two New Directional Ramps or Equivalent.
