## **Access Compliance Report Public Rights-of-Way** (Curb Ramps)

Intersection ID: 4640 Main Street: NORTHBEND DR Cross Street: HERITAGE\_POINTE\_RD Location: ADA ID: 08003D27542A Ramp Type: PerpDiag Initial Pass/Fail: Fail **Overall Compliance: No Severity Score:** 35

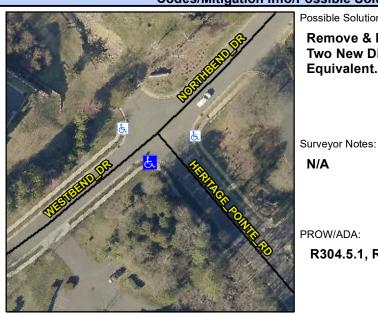
Field Measurements/Component Compliance						
Compliance Description		Data	Comp	liance	Description	Data
N/A	Ramp Length (in)	48.0	No	Ramp	Slope (%)	13.3
No	Ramp Width (in)	44.0	No	Ramp XSlope (%)		4.8
N/A	Flare Type LT	N/A	N/A	A Flare Type RT		N/A
N/A	Flare Slope LT (%)	N/A	N/A	I/A Flare Slope RT (%)		N/A
N/A	Flare Traversable LT?	N/A	N/A	Flare Traversable RT?		N/A
N/A	Landing Length (in)	N/A	N/A	DWS	Provided?	N/A
N/A	Landing Width (in)	N/A	N/A	DWS	Contrast?	N/A
N/A	Landing Slope (%)	N/A	N/A	DWS	Length (in)	N/A
N/A	Landing X Slope (%)	N/A	N/A	DWS	Full Width?	N/A
N/A	Landing Curb? (Y/N)	N/A	N/A	DWS	Offset (in)	N/A
N/A	Shared Landing?	N/A				
N/A	Gutter Ponding?	N/A	N/A	Gutte	r Slope (%)	N/A
N/A	Gutter Lip Ht (in)	N/A	N/A	Gutte	r X Slope (%)	N/A
N/A	Painted X Walk1?	No	N/A	Paint	ed X Walk2?	No
	X Walk 1 Direction	To NE		X Wa	lk 2 Direction	To NW
N/A	X Walk 1 Width (in)	N/A	N/A	X Wa	lk 2 Width (in)	N/A
	X Walk 1 Slope (%)	2.8		X Wa	lk 2 Slope (%)	3.7

X Walk 1 X Slope (%)	3.4		X Wa	lk 2 X Slope (%)	2.7
N/A	Ramp inside XWalk1?	N/A	N/A	Ram	inside XWalk2?	N/A
	Road Slope (%)	3.8	N/A	Clear	Space?	N/A
	Road X Slope (%)	0.2	N/A	Clear	Space to XWalk (in)	N/A
N/A	Any Obstructions?	N/A	N/A	Storn	n Grate/Utility Hazard?	N/A
	Obstruction Type			Storn	n Grate/Utility Type	
		N/A				N/A
			Yes	Surfa	ce Condition? (G/P)	Good

Street 1 Name Stop Condition-Street 2 Street 2 Name Stop Condition-Street 1 HERITAGE POINTE DR None **WESTBEND DR** StopSign Possible Solutions: **Remove & Replace Curb Ramp With** Two New Directional Ramps or Equivalent.

R304.5.1, R304.2.2, R304.5.3
