Access Compliance Report

Public Rights-of-Way

(Curb Ramps)

Intersection ID: 11933	Main Street: E_8TH_ST	Cross Street: N_TRYON_ST	Location: E
ADA ID: 08109D4EB356	Ramp Type: Directional1	Initial Pass/Fail: Fail	Overall Compliance: No
Severity Score: 12.5			
Codes/Mitigation Info/Possible Solution		Field Measurements/Component Compliance

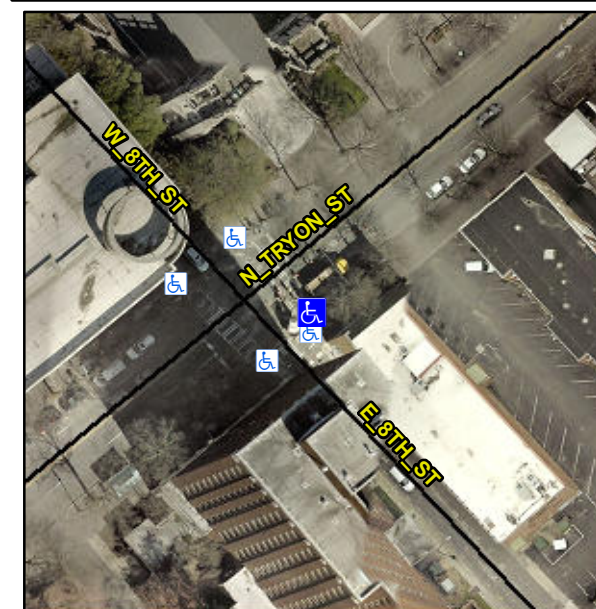
Compliance	Description	Data	Compliance	Description	Data
N/A	Ramp Length (in)	64.0	N/A	Grade Break?	N/A
Yes	Ramp Width (in)	51.0	N/A	Grade Break Slope (%)	0.0
No	Ramp Slope (%)	9.2	N/A	Grade Break XSlope (%)	0.0
Yes	Ramp XSlope (%)	1.3			
N/A	Flare Type LT	N/A	N/A	Flare Type RT	N/A
N/A	Flare Slope LT (%)	N/A	N/A	Flare Slope RT (%)	0.0
N/A	Flare Traversable LT?	N/A	N/A	Flare Traversable RT?	N/A
N/A	Landing Length (in)	0.0	N/A	DWS Provided?	N/A
N/A	Landing Width (in)	0.0	N/A	DWS Contrast?	N/A
N/A	Landing Slope (%)	0.0	N/A	DWS Length (in)	N/A
N/A	Landing X Slope (%)	0.0	N/A	DWS Full Width?	N/A
N/A	Landing Curb? (Y/N)	N/A	N/A	DWS Offset LT (in)	N/A
N/A	Shared Landing?	N/A	N/A	DWS Offset RT (in)	N/A
N/A	Gutter Ponding?	0.0	N/A	Gutter Slope (%)	N/A
N/A	Gutter Lip Ht (in)	0.0	N/A	Gutter X Slope (%)	N/A
N/A	Painted X Walk1?	Yes		Road Slope (%)	5.2
	X Walk 1 Direction	To NW		Road X Slope (%)	4.7
	X Walk 1 Width (in)	124.0		Clear Space?	N/A

X Walk 1 Slope (%)	5.2	N/A	Clear Space to XWalk (in)	N/A
	X Walk 1 X Slope (%)	4.7	N/A	Storm Grate/Utility Hazard?	N/A
N/A	Ramp inside XWalk1?	Yes		Storm Grate/Utility Type	
N/A	Any Obstructions?	N/A			N/A
	Obstruction Type		Yes	Surface Condition? (G/P)	Good
			N/A	Curb Slope (%)	6.1

Possible Solutions:

Remove & Replace Entire Ramp.

R304.2.2
