Access Compliance Report

Public Rights-of-Way

(Curb Ramps)

Intersection ID: 10030167	Main Street: LATROBE_DR	Cross Street: N/A	Location: SE
ADA ID: 0827BAC71A60	Ramp Type: Directional1	Initial Pass/Fail: Fail	Overall Compliance: No
Codes/Mitigation Info/Possible Solution		Field Measurements/Component Compliance	
Severity Score: 21.25

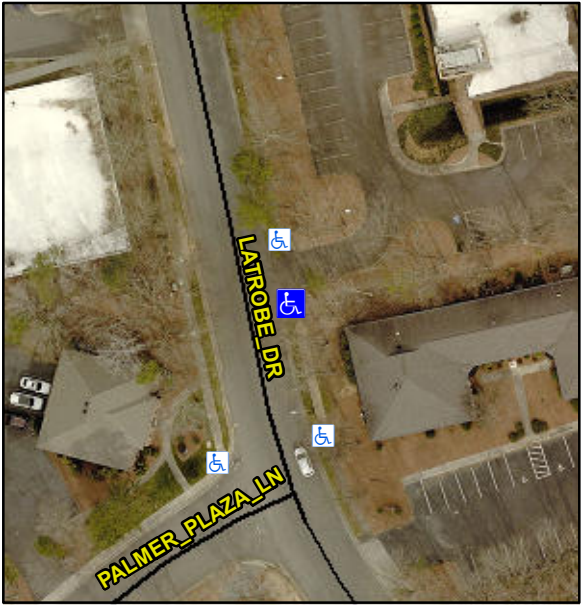
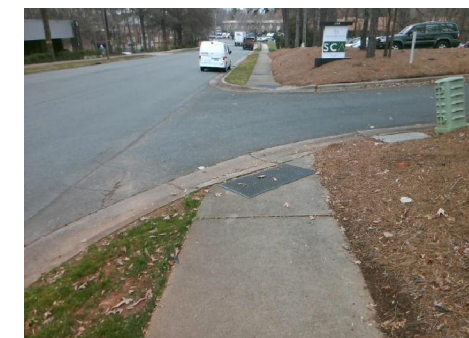
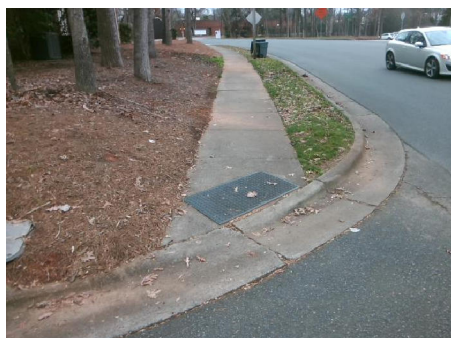
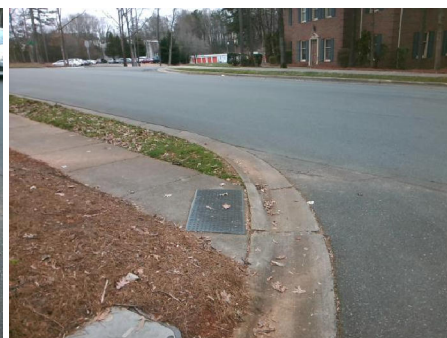
Possible Solutions:		Compliance	Description	Data	Compliance	Description	Data
	Remove & Replace Entire Ramp.		N/A	Ramp Length (in)	48.0	N/A	Grade Break?	N/A
			No	Ramp Width (in)	42.0	N/A	Grade Break Slope (%)	0.0
			Yes	Ramp Slope (%)	3.9	N/A	Grade Break XSlope (%)	0.0
			No	Ramp XSlope (%)	5.8			
			N/A	Flare Type LT	N/A	N/A	Flare Type RT	N/A
			N/A	Flare Slope LT (%)	N/A	N/A	Flare Slope RT (%)	0.0
			N/A	Flare Traversable LT?	N/A	N/A	Flare Traversable RT?	N/A
			N/A	Landing Length (in)	0.0	N/A	DWS Provided?	N/A
			N/A	Landing Width (in)	0.0	N/A	DWS Contrast?	N/A
			N/A	Landing Slope (%)	0.0	N/A	DWS Length (in)	N/A
			N/A	Landing X Slope (%)	0.0	N/A	DWS Full Width?	N/A
			N/A	Landing Curb? (Y/N)	N/A	N/A	DWS Offset LT (in)	N/A
			N/A	Shared Landing?	N/A	N/A	DWS Offset RT (in)	N/A
			N/A	Gutter Ponding?	0.0	N/A	Gutter Slope (%)	N/A
			N/A	Gutter Lip Ht (in)	4.0	N/A	Gutter X Slope (%)	N/A
			N/A	Painted X Walk1?	No		Road Slope (%)	5.5

X Walk 1 Direction	To NW		Road X Slope (%)	6.4
				X Walk 1 Width (in)	N/A		Clear Space?	N/A
				X Walk 1 Slope (%)	5.5	N/A	Clear Space to XWalk (in)	N/A
				X Walk 1 X Slope (%)	6.4	N/A	Storm Grate/Utility Hazard?	N/A
			N/A	Ramp inside XWalk1?	N/A		Storm Grate/Utility Type	
			N/A	Any Obstructions?	N/A			N/A
				Obstruction Type		Yes	Surface Condition? (G/P)	Good
						N/A	Curb Slope (%)	11.4

R304.5.1, R304.5.3

Remove & Replace Entire Ramp.
