Access Compliance Report

Public Rights-of-Way

(Curb Ramps)

Intersection ID: 54156	Main Street: OAKDALE RIDGE RD	Cross Street: MAPLE CREEK CT	Location: NW
ADA ID: 0832D8E39F72	Ramp Type: Perp	Initial Pass/Fail: Fail	Overall Compliance: No
Severity Score: 8.75			
Codes/Mitigation Info/Possible Solution		Field Measurements/Component Compliance

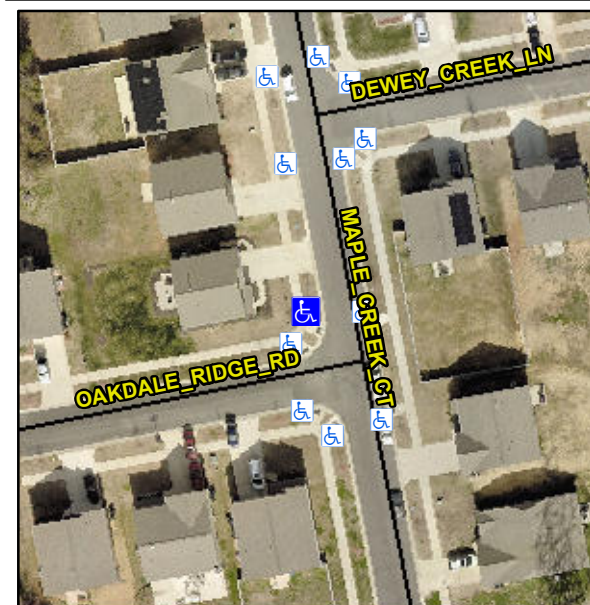
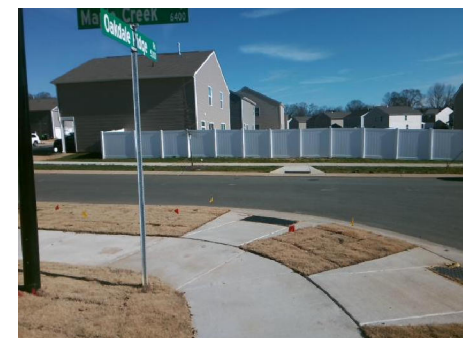
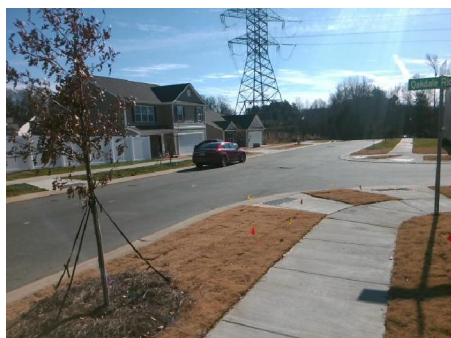
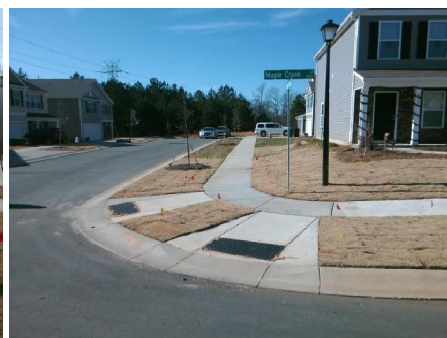
Not Found, R304.5.1

Compliance	Description	Data	Compliance	Description	Data
N/A	Ramp Length (in)	94.5	Yes	Ramp Slope (%)	5.2
No	Ramp Width (in)	46.0	Yes	Ramp XSlope (%)	0.8
N/A	Flare Type LT	N/A	N/A	Flare Type RT	N/A
N/A	Flare Slope LT (%)	N/A	N/A	Flare Slope RT (%)	N/A
N/A	Flare Traversable LT?	N/A	N/A	Flare Traversable RT?	N/A
N/A	Landing Length (in)	N/A	N/A	DWS Provided?	N/A
N/A	Landing Width (in)	N/A	N/A	DWS Contrast?	N/A
N/A	Landing Slope (%)	N/A	N/A	DWS Length (in)	N/A
N/A	Landing X Slope (%)	N/A	N/A	DWS Full Width?	N/A
N/A	Landing Curb? (Y/N)	N/A	N/A	DWS Offset (in)	N/A
N/A	Shared Landing?	N/A			
N/A	Gutter Ponding?	N/A	N/A	Gutter Slope (%)	N/A
N/A	Gutter Lip Ht (in)	1.3	N/A	Gutter X Slope (%)	N/A
N/A	Painted X Walk1?	No	N/A	Painted X Walk2?	N/A
	X Walk 1 Direction	To E		X Walk 2 Direction	N/A
N/A	X Walk 1 Width (in)	N/A	N/A	X Walk 2 Width (in)	N/A
	X Walk 1 Slope (%)	4.1		X Walk 2 Slope (%)	N/A
	X Walk 1 X Slope (%)	2.4		X Walk 2 X Slope (%)	N/A

N/A	Ramp inside XWalk1?	N/A	N/A	Ramp inside XWalk2?	N/A
	Road Slope (%)	N/A	N/A	Clear Space?	N/A
	Road X Slope (%)	N/A	N/A	Clear Space to XWalk (in)	N/A
N/A	Any Obstructions?	N/A	N/A	Storm Grate/Utility Hazard?	N/A
	Obstruction Type			Storm Grate/Utility Type	
		N/A			N/A
			Yes	Surface Condition? (G/P)	Good

Possible Solutions:

Remove & Replace Entire Ramp.
