Access Compliance Report

Public Rights-of-Way

(Curb Ramps)

Intersection ID: 42765	Main Street: CRUTCHFIELD_PL	Cross Street: WINSTON_OAKS_CT	Location: NE
ADA ID: 0835CBEB0592	Ramp Type: PerpDiag	Initial Pass/Fail: Fail	Overall Compliance: No
Severity Score: 22.5			
Codes/Mitigation Info/Possible Solution		Field Measurements/Component Compliance

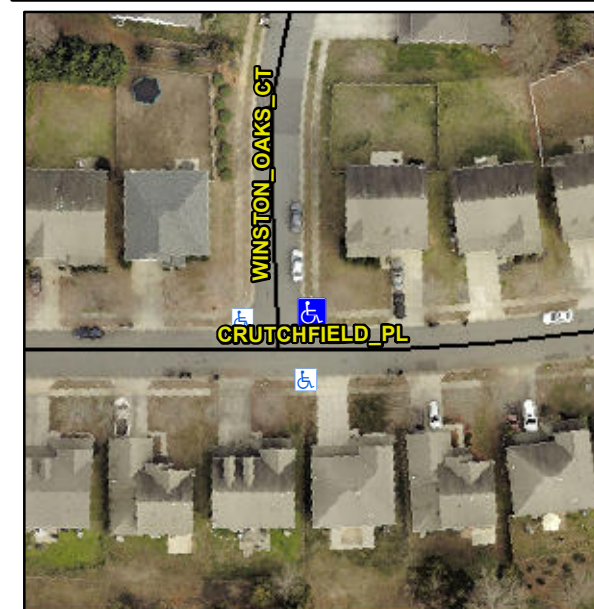
Not Found, R304.5.1, R304.2.2, R304.5.3

Compliance	Description	Data	Compliance	Description	Data
N/A	Ramp Length (in)	51.0	No	Ramp Slope (%)	9.9
No	Ramp Width (in)	40.0	No	Ramp XSlope (%)	2.1
N/A	Flare Type LT	N/A	N/A	Flare Type RT	N/A
N/A	Flare Slope LT (%)	N/A	N/A	Flare Slope RT (%)	N/A
N/A	Flare Traversable LT?	N/A	N/A	Flare Traversable RT?	N/A
N/A	Landing Length (in)	N/A	N/A	DWS Provided?	N/A
N/A	Landing Width (in)	N/A	N/A	DWS Contrast?	N/A
N/A	Landing Slope (%)	N/A	N/A	DWS Length (in)	N/A
N/A	Landing X Slope (%)	N/A	N/A	DWS Full Width?	N/A
N/A	Landing Curb? (Y/N)	N/A	N/A	DWS Offset (in)	N/A
N/A	Shared Landing?	N/A			
N/A	Gutter Ponding?	N/A	N/A	Gutter Slope (%)	N/A
N/A	Gutter Lip Ht (in)	N/A	N/A	Gutter X Slope (%)	N/A
N/A	Painted X Walk1?	No	N/A	Painted X Walk2?	No
	X Walk 1 Direction	To W		X Walk 2 Direction	To S
N/A	X Walk 1 Width (in)	N/A	N/A	X Walk 2 Width (in)	N/A
	X Walk 1 Slope (%)	8.9		X Walk 2 Slope (%)	9.5
	X Walk 1 X Slope (%)	1.0		X Walk 2 X Slope (%)	5.8

N/A	Ramp inside XWalk1?	N/A	N/A	Ramp inside XWalk2?	N/A
	Road Slope (%)	2.4	N/A	Clear Space?	N/A
	Road X Slope (%)	9.5	N/A	Clear Space to XWalk (in)	N/A
N/A	Any Obstructions?	N/A	N/A	Storm Grate/Utility Hazard?	N/A
	Obstruction Type			Storm Grate/Utility Type	
		N/A			N/A
		Yes		Surface Condition? (G/P)	Good

Possible Solutions:

Remove & Replace Curb Ramp With Two New Directional Ramps or Equivalent.
