# Access Compliance Report

## Public Rights-of-Way

### (Curb Ramps)

Intersection ID: 10026441	Main Street: FARMHURST_DR	Cross Street: N/A	Location: SE
ADA ID: 0837FEBB6A3E	Ramp Type: BlendTrans1	Initial Pass/Fail: Fail	Overall Compliance: No
		Severity Score: 12.5	
Codes/Mitigation Info/Possible Solution		Field Measurements/Component Compliance

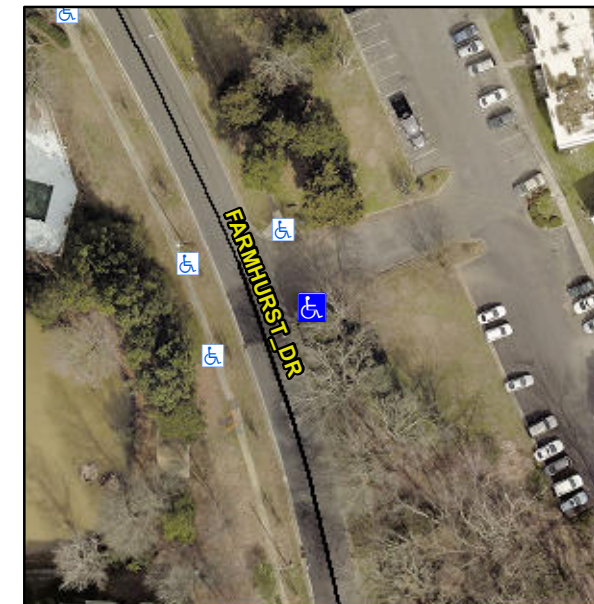
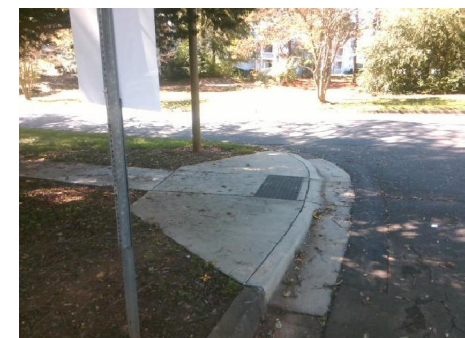
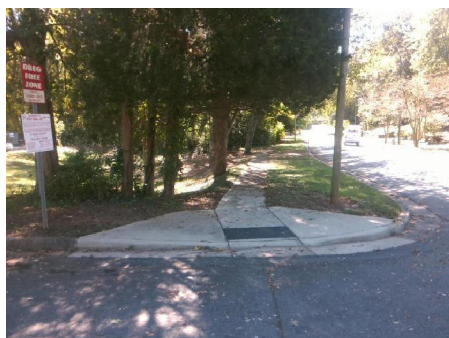
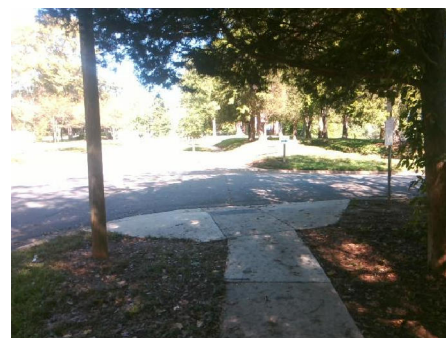
**Not Found, R304.5.3**

Compliance	Description	Data	Compliance	Description	Data
N/A	Ramp Length (in)	92.0	Yes	BlendTrans Slope (%)	3.3
Yes	Ramp Width (in)	48.0	No	BlendTrans XSlope (%)	6.4
N/A	Flare Type LT	N/A	N/A	Flare Type RT	N/A
N/A	Flare Slope LT (%)	N/A	N/A	Flare Slope RT (%)	N/A
N/A	Flare Traversable LT?	N/A	N/A	Flare Traversable RT?	N/A
N/A	Landing Length (in)	N/A	N/A	DWS Provided?	N/A
N/A	Landing Width (in)	N/A	N/A	DWS Contrast?	N/A
N/A	Landing Slope (%)	N/A	N/A	DWS Length (in)	N/A
N/A	Landing X Slope (%)	N/A	N/A	DWS Full Width?	N/A
N/A	Landing Curb? (Y/N)	N/A	N/A	DWS Offset (in)	N/A
N/A	Shared Landing?	N/A			
N/A	Gutter Ponding?	N/A	N/A	Gutter Slope (%)	N/A
N/A	Gutter Lip Ht (in)	N/A	N/A	Gutter X Slope (%)	N/A
N/A	Painted X Walk1?	No	N/A	Painted X Walk2?	No
	X Walk 1 Direction	To NW		X Walk 2 Direction	To SW
	X Walk 1 Width (in)	N/A		X Walk 2 Width (in)	N/A
	X Walk 1 Slope (%)	9.7		X Walk 2 Slope (%)	3.6
	X Walk 1 X Slope (%)	1.6		X Walk 2 X Slope (%)	10.1

N/A	Ramp inside XWalk1?	N/A	N/A	Ramp inside XWalk2?	N/A
	Road Slope (%)	2.8		Clear Space?	N/A
	Road X Slope (%)	10.4	N/A	Clear Space to XWalk (in)	N/A
N/A	Any Obstructions?	N/A	N/A	Storm Grate/Utility Hazard?	N/A
	Obstruction Type			Storm Grate/Utility Type	
		N/A			N/A
			Yes	Surface Condition? (G/P)	Good
			No	Curb Slope (%)	19.4

**Remove & Replace Curb Ramp With Two New Directional Ramps or Equivalent.**
