Access Compliance Report

Public Rights-of-Way

(Curb Ramps)

Intersection ID: 5058	Main Street: KILLARNEY_PL	Cross Street: MORNING_GLORY_DR	Location:	N
ADA ID: 0843C49E984F	Ramp Type: Perp	Initial Pass/Fail: Fail	Overall Compliance: No	Severity Score: 50

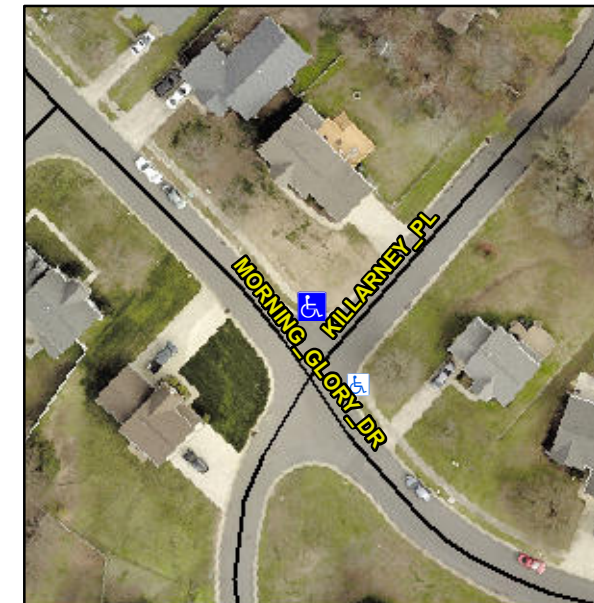
Not Found, R304.2.2, R304.5.3

Compliance	Description	Data	Compliance	Description	Data
N/A	Ramp Length (in)	45.0	No	Ramp Slope (%)	13.4
Yes	Ramp Width (in)	48.0	No	Ramp XSlope (%)	11.8
N/A	Flare Type LT	N/A	N/A	Flare Type RT	N/A
N/A	Flare Slope LT (%)	N/A	N/A	Flare Slope RT (%)	N/A
N/A	Flare Traversable LT?	N/A	N/A	Flare Traversable RT?	N/A
N/A	Landing Length (in)	N/A	N/A	DWS Provided?	N/A
N/A	Landing Width (in)	N/A	N/A	DWS Contrast?	N/A
N/A	Landing Slope (%)	N/A	N/A	DWS Length (in)	N/A
N/A	Landing X Slope (%)	N/A	N/A	DWS Full Width?	N/A
N/A	Landing Curb? (Y/N)	N/A	N/A	DWS Offset (in)	N/A
N/A	Shared Landing?	N/A			
N/A	Gutter Ponding?	N/A	N/A	Gutter Slope (%)	N/A
N/A	Gutter Lip Ht (in)	N/A	N/A	Gutter X Slope (%)	N/A
N/A	Painted X Walk1?	No	N/A	Painted X Walk2?	N/A
	X Walk 1 Direction	To SE		X Walk 2 Direction	N/A
N/A	X Walk 1 Width (in)	N/A	N/A	X Walk 2 Width (in)	N/A
	X Walk 1 Slope (%)	7.2		X Walk 2 Slope (%)	N/A
	X Walk 1 X Slope (%)	0.4		X Walk 2 X Slope (%)	N/A

Remove & Replace Entire Ramp.
