# Access Compliance Report

## Public Rights-of-Way

### (Curb Ramps)

| Intersection ID: N/A | Main Street: BROOKVALE_ST | Cross Street: HORACE_ST | Location: SE |

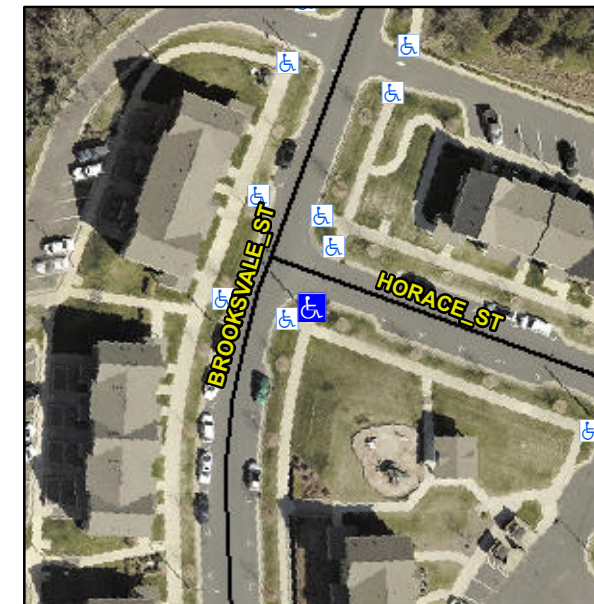
| ADA ID: 0844C41CBB76 | Ramp Type: Perp | Initial Pass/Fail: Fail | Overall Compliance: No |
| Severity Score: 12.5 | | | |

**Not Found, R304.2.2**

| Compliance | Description | Data | Compliance | Description | Data |
|---|---|---|---|---|---|
| N/A | Ramp Length (in) | 72.0 | No | Ramp Slope (%) | 8.7 |

**Remove & Replace Entire Ramp.**

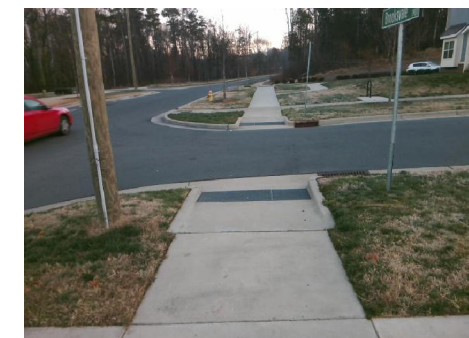
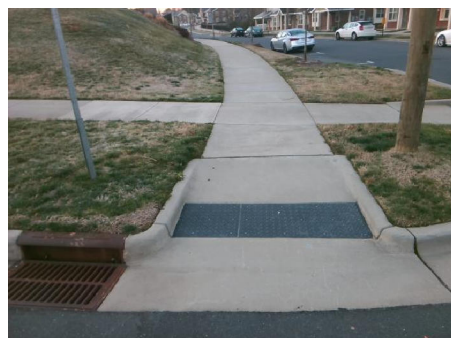
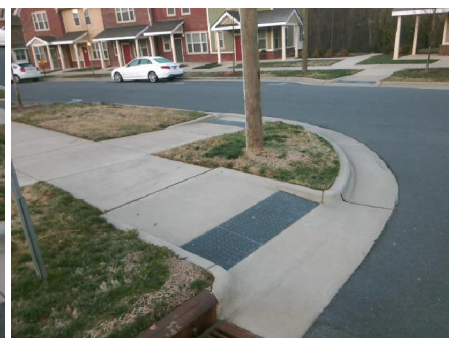
| Compliance | Description | Data | Compliance | Description | Data |
|---|---|---|---|---|---|
| Yes | Ramp Width (in) | 70.0 | Yes | Ramp XSlope (%) | 1.9 |
| | | | Yes | Surface Condition? (G/P) | Good |
