Access Compliance Report

Public Rights-of-Way

(Curb Ramps)

Intersection ID: 5975		Main Street: DELLINGER_DR		Cross Street: SUNSTONE_DR		Location: SW											
ADA ID: 084990E7D9EA		Ramp Type: Directional1		Initial Pass/Fail: Fail		Overall Compliance: No		Severity Score: 10									
Codes/Mitigation Info/Possible Solution				Field Measurements/Component Compliance													
<div>

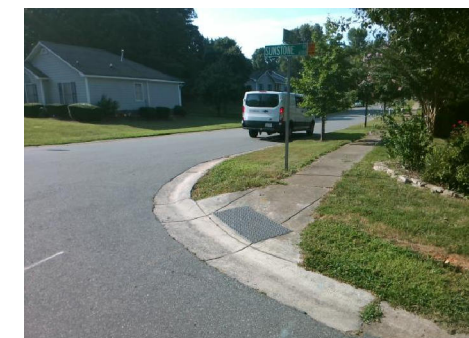
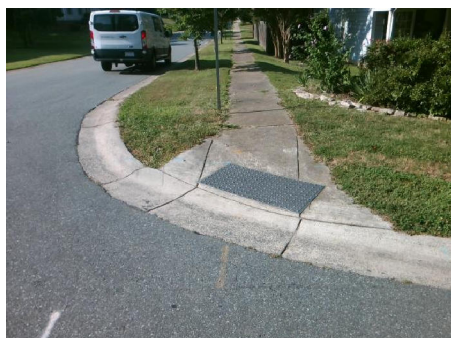
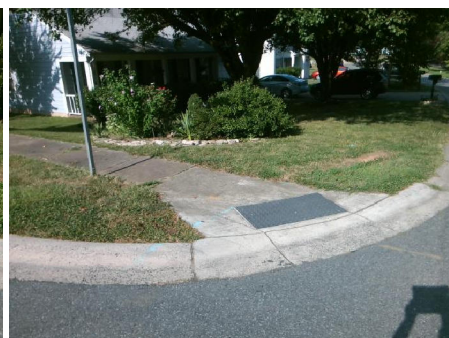
Yes		Ramp Slope (%)		5.9		N/A		Grade Break XSlope (%)		0.0			
				Yes		Ramp XSlope (%)		4.1									
				N/A		Flare Type LT		N/A		N/A		Flare Type RT		N/A			
				N/A		Flare Slope LT (%)		N/A		N/A		Flare Slope RT (%)		0.0			
				N/A		Flare Traversable LT?		N/A		N/A		Flare Traversable RT?		N/A			
				N/A		Landing Length (in)		0.0		N/A		DWS Provided?		N/A			
				N/A		Landing Width (in)		0.0		N/A		DWS Contrast?		N/A			
				N/A		Landing Slope (%)		0.0		N/A		DWS Length (in)		N/A			
				N/A		Landing X Slope (%)		0.0		N/A		DWS Full Width?		N/A			
				N/A		Landing Curb? (Y/N)		N/A		N/A		DWS Offset LT (in)		N/A			
				N/A		Shared Landing?		N/A		N/A		DWS Offset RT (in)		N/A			
				N/A		Gutter Ponding?		0.0		N/A		Gutter Slope (%)		N/A			
				N/A		Gutter Lip Ht (in)		0.0		N/A		Gutter X Slope (%)		N/A			
				N/A		Painted X Walk1?		No				Road Slope (%)		3.1			
						X Walk 1 Direction		To N				Road X Slope (%)		5.1

X Walk 1 Width (in)		N/A				Clear Space?		N/A			
						X Walk 1 Slope (%)		3.1		N/A		Clear Space to XWalk (in)		N/A			
						X Walk 1 X Slope (%)		5.1		N/A		Storm Grate/Utility Hazard?		N/A			
				N/A		Ramp inside XWalk1?		N/A				Storm Grate/Utility Type					
				N/A		Any Obstructions?		N/A						N/A			
						Obstruction Type				Yes		Surface Condition? (G/P)		Good			
										N/A		N/A		Curb Slope (%)		9.1
