# Access Compliance Report

## Public Rights-of-Way

### (Curb Ramps)

Intersection ID: 9069	Main Street: HEIL_PL	Cross Street: MULBERRY_AV	Location: S
ADA ID: 085A52E7AA76	Ramp Type: Perp	Initial Pass/Fail: Fail	Overall Compliance: No
		Severity Score: 12.5

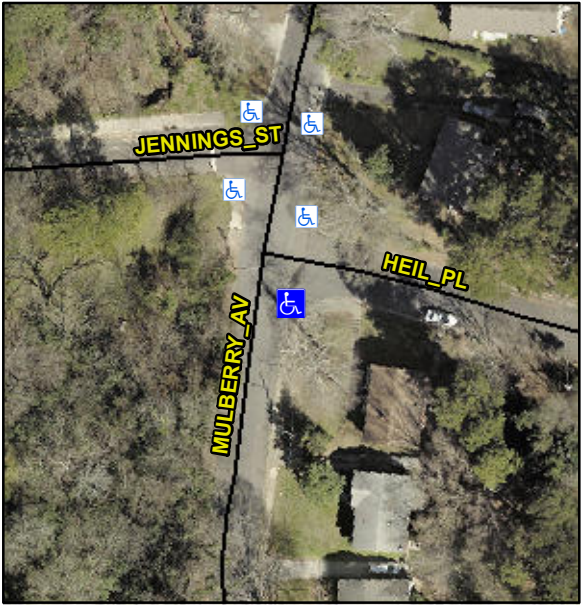
Possible Solutions:		<b>Compliance</b>	<b>Description</b>	<b>Data</b>
	Remove & Replace Entire Ramp.		N/A	Ramp Length (in)	25.0
			Yes	Ramp Width (in)	48.0
			N/A	Flare Type LT	N/A
			N/A	Flare Slope LT (%)	N/A
			N/A	Flare Traversable LT?	N/A
			N/A	Landing Length (in)	N/A
			N/A	Landing Width (in)	N/A
			N/A	Landing Slope (%)	N/A
			N/A	Landing X Slope (%)	N/A
<p>Surveyor Notes:</p> <p>N/A</p> <p>PROW/ADA:</p> <p>Not Found, R304.5.3</p>			N/A	Flare Type RT	N/A
			N/A	Flare Slope RT (%)	N/A
			N/A	Flare Traversable RT?	N/A
			N/A	DWS Provided?	N/A
			N/A	DWS Contrast?	N/A
			N/A	DWS Length (in)	N/A
			N/A	DWS Full Width?	N/A
			N/A	DWS Offset (in)	N/A
			N/A	Shared Landing?	N/A
			N/A	Gutter Ponding?	N/A
			N/A	Gutter Lip Ht (in)	N/A
			N/A	Painted X Walk1?	No
				X Walk 1 Direction	To NE
			N/A	X Walk 1 Width (in)	N/A
				X Walk 1 Slope (%)	4.2

X Walk 1 X Slope (%)	2.6
			N/A	Ramp inside XWalk1?	N/A
			N/A	Road Slope (%)	N/A
			N/A	Road X Slope (%)	N/A
			N/A	Any Obstructions?	N/A
				Obstruction Type	
Total Cost:			\$	1850.00
