Access Compliance Report

Public Rights-of-Way

(Curb Ramps)

Intersection ID: 13959	Main Street: CLEVELAND_AV	Cross Street: E_PARK_AV	Location: W
ADA ID: 0862DBA46E7E	Ramp Type: Perp	Initial Pass/Fail: Fail	Overall Compliance: No
Severity Score: 13.75			
Codes/Mitigation Info/Possible Solution		Field Measurements/Component Compliance

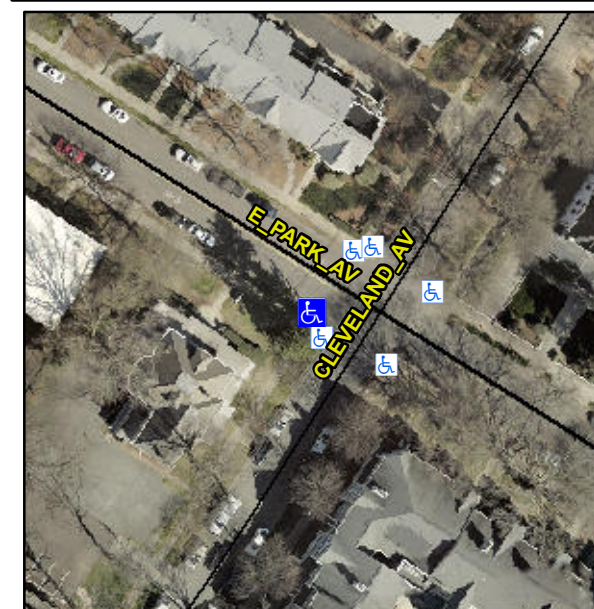
Not Found, R304.2.2, R304.5.3

Compliance	Description	Data	Compliance	Description	Data
N/A	Ramp Length (in)	38.0	No	Ramp Slope (%)	8.9
Yes	Ramp Width (in)	110.0	No	Ramp XSlope (%)	3.2
N/A	Flare Type LT	N/A	N/A	Flare Type RT	N/A
N/A	Flare Slope LT (%)	N/A	N/A	Flare Slope RT (%)	N/A
N/A	Flare Traversable LT?	N/A	N/A	Flare Traversable RT?	N/A
N/A	Landing Length (in)	N/A	N/A	DWS Provided?	N/A
N/A	Landing Width (in)	N/A	N/A	DWS Contrast?	N/A
N/A	Landing Slope (%)	N/A	N/A	DWS Length (in)	N/A
N/A	Landing X Slope (%)	N/A	N/A	DWS Full Width?	N/A
N/A	Landing Curb? (Y/N)	N/A	N/A	DWS Offset (in)	N/A
N/A	Shared Landing?	N/A			
N/A	Gutter Ponding?	N/A	N/A	Gutter Slope (%)	N/A
N/A	Gutter Lip Ht (in)	N/A	N/A	Gutter X Slope (%)	N/A
N/A	Painted X Walk1?	No	N/A	Painted X Walk2?	N/A
	X Walk 1 Direction	To NE		X Walk 2 Direction	N/A
N/A	X Walk 1 Width (in)	N/A	N/A	X Walk 2 Width (in)	N/A
	X Walk 1 Slope (%)	4.8		X Walk 2 Slope (%)	N/A
	X Walk 1 X Slope (%)	0.9		X Walk 2 X Slope (%)	N/A

N/A	Ramp inside XWalk1?	N/A	N/A	Ramp inside XWalk2?	N/A
	Road Slope (%)	N/A	N/A	Clear Space?	N/A
	Road X Slope (%)	N/A	N/A	Clear Space to XWalk (in)	N/A
N/A	Any Obstructions?	N/A	N/A	Storm Grate/Utility Hazard?	N/A
	Obstruction Type			Storm Grate/Utility Type	
		N/A			N/A
			Yes	Surface Condition? (G/P)	Good

Remove & Replace Entire Ramp.
