Access Compliance Report

Public Rights-of-Way

(Curb Ramps)

Intersection ID: 21514	Main Street: ARROWOOD_RD	Cross Street: NATIONS_FORD_RD	Location: SW
ADA ID: 086ACD8CB44D	Ramp Type: Perp	Initial Pass/Fail: Fail	Overall Compliance: No
Severity Score: 12.5			
Codes/Mitigation Info/Possible Solution		Field Measurements/Component Compliance

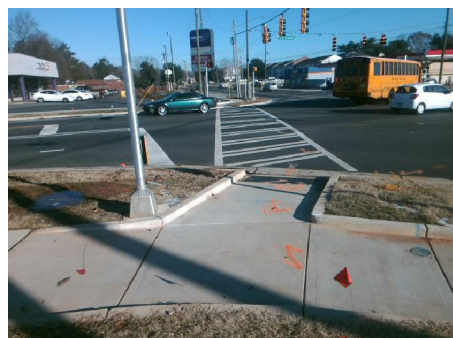
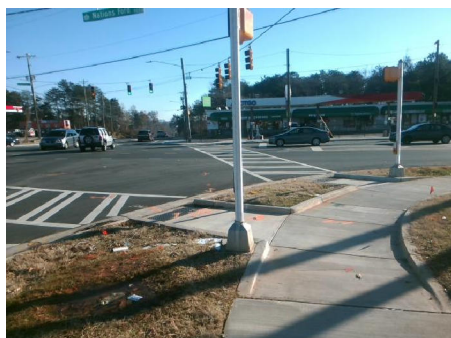
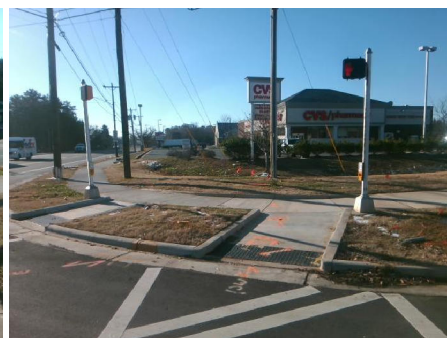
Compliance	Description	Data	Compliance	Description	Data
N/A	Ramp Length (in)	112.0	Yes	Ramp Slope (%)	6.8
Yes	Ramp Width (in)	70.0	No	Ramp XSlope (%)	6.4
N/A	Flare Type LT	N/A	N/A	Flare Type RT	N/A
N/A	Flare Slope LT (%)	N/A	N/A	Flare Slope RT (%)	N/A
N/A	Flare Traversable LT?	N/A	N/A	Flare Traversable RT?	N/A
N/A	Landing Length (in)	N/A	N/A	DWS Provided?	N/A
N/A	Landing Width (in)	N/A	N/A	DWS Contrast?	N/A
N/A	Landing Slope (%)	N/A	N/A	DWS Length (in)	N/A
N/A	Landing X Slope (%)	N/A	N/A	DWS Full Width?	N/A
N/A	Landing Curb? (Y/N)	N/A	N/A	DWS Offset (in)	N/A
N/A	Shared Landing?	N/A			
N/A	Gutter Ponding?	N/A	N/A	Gutter Slope (%)	N/A
N/A	Gutter Lip Ht (in)	N/A	N/A	Gutter X Slope (%)	N/A
N/A	Painted X Walk1?	Yes	N/A	Painted X Walk2?	N/A
	X Walk 1 Direction	To N		X Walk 2 Direction	N/A
N/A	X Walk 1 Width (in)	108.0	N/A	X Walk 2 Width (in)	N/A
	X Walk 1 Slope (%)	0.1		X Walk 2 Slope (%)	N/A
	X Walk 1 X Slope (%)	0.6		X Walk 2 X Slope (%)	N/A

N/A	Ramp inside XWalk1?	Yes	N/A	Ramp inside XWalk2?	N/A
	Road Slope (%)	N/A	N/A	Clear Space?	N/A
	Road X Slope (%)	N/A	N/A	Clear Space to XWalk (in)	N/A
N/A	Any Obstructions?	N/A	N/A	Storm Grate/Utility Hazard?	N/A
	Obstruction Type			Storm Grate/Utility Type	
		N/A			N/A
		Yes		Surface Condition? (G/P)	Good

Possible Solutions:

Remove & Replace Entire Ramp.
