Access Compliance Report

Public Rights-of-Way

(Curb Ramps)

Intersection ID: 5090	Main Street: EDMONTON_PL	Cross Street: SARNIA_PL	Location:	S
ADA ID: 087DB7F68D88	Ramp Type: Perp	Initial Pass/Fail: Fail	Overall Compliance: No	Severity Score: 50

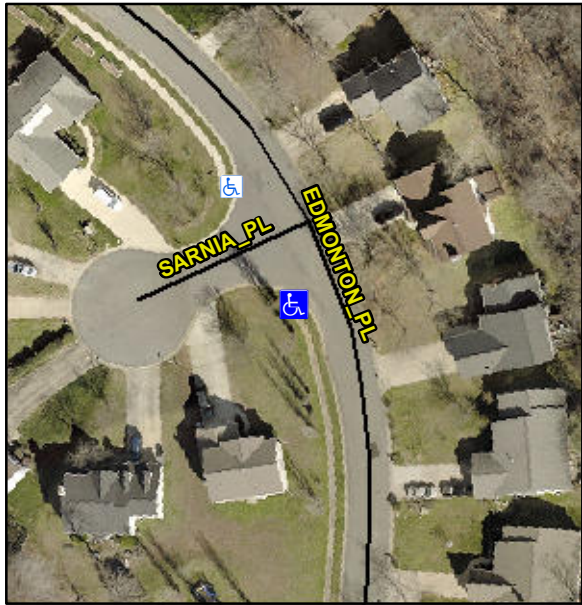
Possible Solutions:		Compliance	Description	Data	Compliance	Description	Data
	Remove & Replace Entire Ramp.		N/A	Ramp Length (in)	48.0	No	Ramp Slope (%)	20.0
			No	Ramp Width (in)	47.0	No	Ramp XSlope (%)	3.1
			N/A	Flare Type LT	N/A	N/A	Flare Type RT	N/A
			N/A	Flare Slope LT (%)	N/A	N/A	Flare Slope RT (%)	N/A
			N/A	Flare Traversable LT?	N/A	N/A	Flare Traversable RT?	N/A
			N/A	Landing Length (in)	N/A	N/A	DWS Provided?	N/A
			N/A	Landing Width (in)	N/A	N/A	DWS Contrast?	N/A
			N/A	Landing Slope (%)	N/A	N/A	DWS Length (in)	N/A
			N/A	Landing X Slope (%)	N/A	N/A	DWS Full Width?	N/A
Surveyor Notes:	N/A		N/A	Landing Curb? (Y/N)	N/A	N/A	DWS Offset (in)	N/A
			N/A	Shared Landing?	N/A			
	PROW/ADA:		N/A	Gutter Ponding?	N/A	N/A	Gutter Slope (%)	N/A
	Not Found, R304.5.1, R304.2.2, R304.5.3, R302.7		N/A	Gutter Lip Ht (in)	N/A	N/A	Gutter X Slope (%)	N/A

N/A	Painted X Walk1?	No	N/A	Painted X Walk2?	N/A
				X Walk 1 Direction	To N		X Walk 2 Direction	N/A
			N/A	X Walk 1 Width (in)	N/A	N/A	X Walk 2 Width (in)	N/A
				X Walk 1 Slope (%)	1.2		X Walk 2 Slope (%)	N/A
				X Walk 1 X Slope (%)	1.7		X Walk 2 X Slope (%)	N/A
			N/A	Ramp inside XWalk1?	N/A	N/A	Ramp inside XWalk2?	N/A
			Road Slope (%)	N/A	N/A	Clear Space?	N/A	
			Road X Slope (%)	N/A	N/A	Clear Space to XWalk (in)	N/A	
		N/A	Any Obstructions?	N/A	N/A	Storm Grate/Utility Hazard?	N/A	
			Obstruction Type			Storm Grate/Utility Type		
					N/A		N/A	
					No	Surface Condition? (G/P)	Poor
