Access Compliance Report Public Rights-of-Way (Curb Ramps)

| | | • | | | | | | | |
|--|---|---|---|--|---|---|---|---|---|
| Intersection ID: 53227 | Main Street: MAJOR_SAMUALS_WY | | | s Street: | EVERGREEN_DR | Location: | SW | | |
| ADA ID: 08808381C078 | Ramp Type: Perp | | | Initial Pass/Fail: Fail Overall Compliance: No | | | | o Severity Score: | 8.75 |

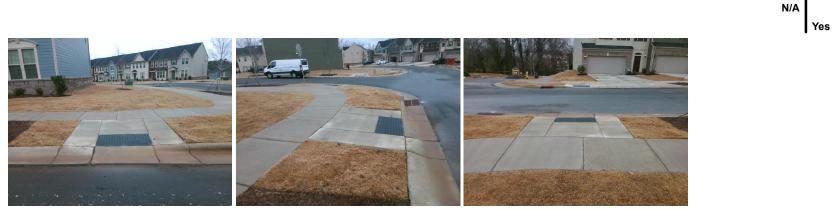
| | | • | | | | | | | |
|--|---|---|---|--|---|---|---|---|---|
| | Ger . | Remove & Replace Entire Rar | np. | N/A | Ramp Length (in) | 72.0 | Yes | Ramp Slope (%) | 7.5 |
| | | | | No | Ramp Width (in) | 47.5 | Yes | Ramp XSlope (%) | 2.0 |
| PROW/ADA: Not Found, R304.5.1 | | | | N/A | Landing Curb? (Y/N) | N/A | N/A | DWS Offset (in) | N/A |

| | | • | | | | | | | |
|--|---|---|---|--|---|---|---|---|---|
| | | Total Cost: \$ | 1850.00 | | Obstruction Type | | | Storm Grate/Utility Type | |
