Access Compliance Report

Public Rights-of-Way

(Curb Ramps)

Intersection ID: N/A	Main Street: S BREVARD ST	Cross Street: E 3RD ST	Location: W
ADA ID: 08828D6ED711	Ramp Type: Perp	Initial Pass/Fail: Fail	Overall Compliance: No
		Severity Score: 12.5

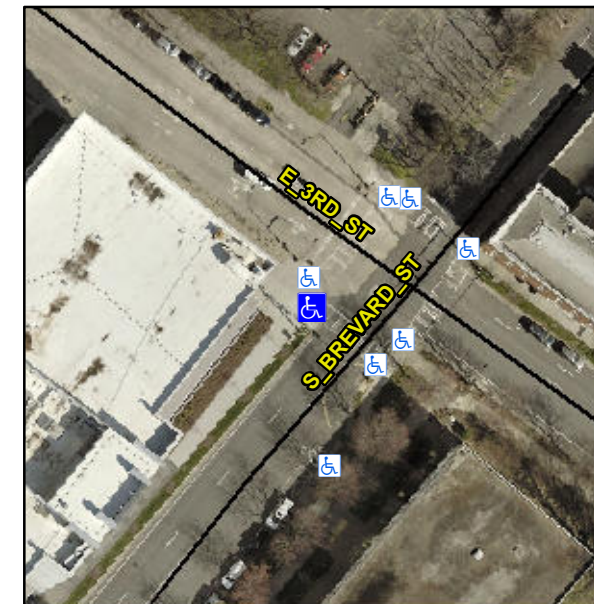
Not Found, R304.2.2

Compliance	Description	Data	Compliance	Description	Data
N/A	Ramp Length (in)	70.0	No	Ramp Slope (%)	10.3
Yes	Ramp Width (in)	48.0	Yes	Ramp XSlope (%)	0.3
N/A	Flare Type LT	N/A	N/A	Flare Type RT	N/A
N/A	Flare Slope LT (%)	N/A	N/A	Flare Slope RT (%)	N/A
N/A	Flare Traversable LT?	No	N/A	Flare Traversable RT?	No
N/A	Landing Length (in)	N/A	N/A	DWS Provided?	N/A
N/A	Landing Width (in)	N/A	N/A	DWS Contrast?	N/A
N/A	Landing Slope (%)	N/A	N/A	DWS Length (in)	N/A
N/A	Landing X Slope (%)	N/A	N/A	DWS Full Width?	N/A
N/A	Landing Curb? (Y/N)	N/A	N/A	DWS Offset (in)	N/A
N/A	Shared Landing?	N/A			
N/A	Gutter Ponding?	N/A	N/A	Gutter Slope (%)	N/A
N/A	Gutter Lip Ht (in)	N/A	N/A	Gutter X Slope (%)	N/A
N/A	Painted X Walk1?	Yes	N/A	Painted X Walk2?	N/A
	X Walk 1 Direction	To SE		X Walk 2 Direction	N/A
N/A	X Walk 1 Width (in)	104.0	N/A	X Walk 2 Width (in)	N/A
	X Walk 1 Slope (%)	5.4		X Walk 2 Slope (%)	N/A
	X Walk 1 X Slope (%)	0.9		X Walk 2 X Slope (%)	N/A

N/A	Ramp inside XWalk1?	Yes	N/A	Ramp inside XWalk2?	N/A
	Road Slope (%)	N/A	N/A	Clear Space?	N/A
	Road X Slope (%)	N/A	N/A	Clear Space to XWalk (in)	N/A
N/A	Any Obstructions?	N/A	N/A	Storm Grate/Utility Hazard?	N/A
	Obstruction Type			Storm Grate/Utility Type	
		N/A			N/A
		Yes		Surface Condition? (G/P)	Good

Possible Solutions:

Remove & Replace Entire Ramp.

Total Cost: \$ 1850.00
