Access Compliance Report

Public Rights-of-Way

(Curb Ramps)

Intersection ID: 47270	Main Street: MARVILLE_CT	Cross Street: SAVANNAH_HILLS_DR	Location: NE
ADA ID: 08876D03916A	Ramp Type: Perp	Initial Pass/Fail: Fail	Overall Compliance: No
Codes/Mitigation Info/Possible Solution		Field Measurements/Component Compliance	
Severity Score: 10

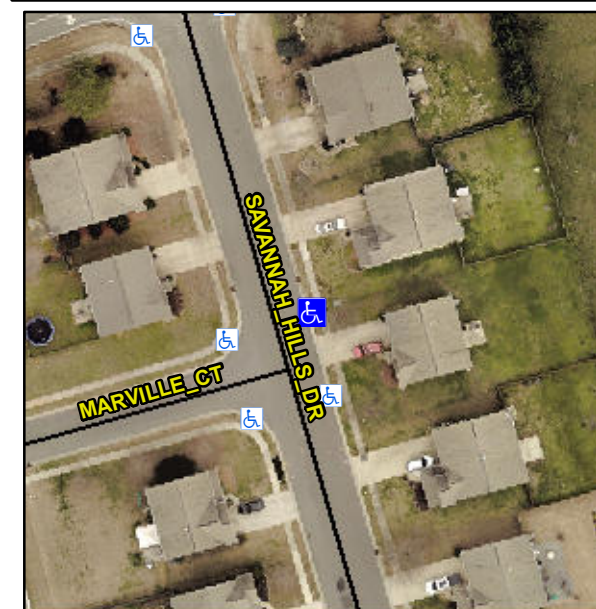
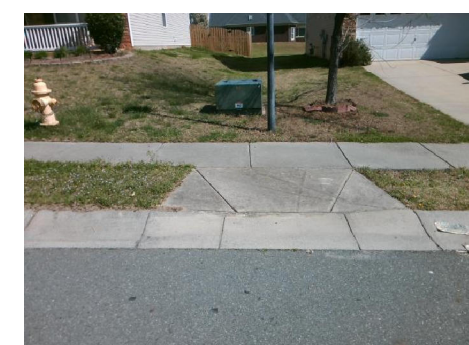
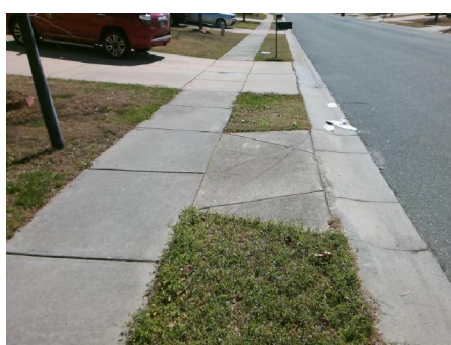
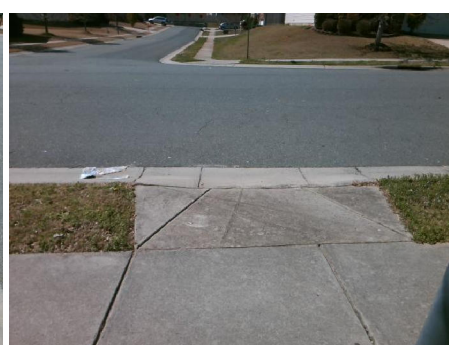
Not Found, R304.5.1

Compliance	Description	Data	Compliance	Description	Data
N/A	Ramp Length (in)	46.0	Yes	Ramp Slope (%)	6.5
No	Ramp Width (in)	38.0	Yes	Ramp XSlope (%)	3.7
N/A	Flare Type LT	N/A	N/A	Flare Type RT	N/A
N/A	Flare Slope LT (%)	N/A	N/A	Flare Slope RT (%)	N/A
N/A	Flare Traversable LT?	N/A	N/A	Flare Traversable RT?	N/A
N/A	Landing Length (in)	N/A	N/A	DWS Provided?	N/A
N/A	Landing Width (in)	N/A	N/A	DWS Contrast?	N/A
N/A	Landing Slope (%)	N/A	N/A	DWS Length (in)	N/A
N/A	Landing X Slope (%)	N/A	N/A	DWS Full Width?	N/A
N/A	Landing Curb? (Y/N)	N/A	N/A	DWS Offset (in)	N/A
N/A	Shared Landing?	N/A			
N/A	Gutter Ponding?	N/A	N/A	Gutter Slope (%)	N/A
N/A	Gutter Lip Ht (in)	N/A	N/A	Gutter X Slope (%)	N/A
N/A	Painted X Walk1?	No	N/A	Painted X Walk2?	N/A
	X Walk 1 Direction	To W		X Walk 2 Direction	N/A
N/A	X Walk 1 Width (in)	N/A	N/A	X Walk 2 Width (in)	N/A
	X Walk 1 Slope (%)	6.5		X Walk 2 Slope (%)	N/A
	X Walk 1 X Slope (%)	4.1		X Walk 2 X Slope (%)	N/A

N/A	Ramp inside XWalk1?	N/A	N/A	Ramp inside XWalk2?	N/A
	Road Slope (%)	N/A	N/A	Clear Space?	N/A
	Road X Slope (%)	N/A	N/A	Clear Space to XWalk (in)	N/A
N/A	Any Obstructions?	N/A	N/A	Storm Grate/Utility Hazard?	N/A
	Obstruction Type			Storm Grate/Utility Type	
		N/A			N/A
			Yes	Surface Condition? (G/P)	Good

Remove & Replace Entire Ramp.
