# Access Compliance Report

## Public Rights-of-Way

### (Curb Ramps)

Intersection ID: 16629	Main Street: HAVERHILL_DR	Cross Street: SCALEYBARK_RD	Location:	W
ADA ID: 0887756737BE	Ramp Type: Directional1	Initial Pass/Fail: Fail	Overall Compliance: No	Severity Score: 1.25
Codes/Mitigation Info/Possible Solution		Field Measurements/Component Compliance

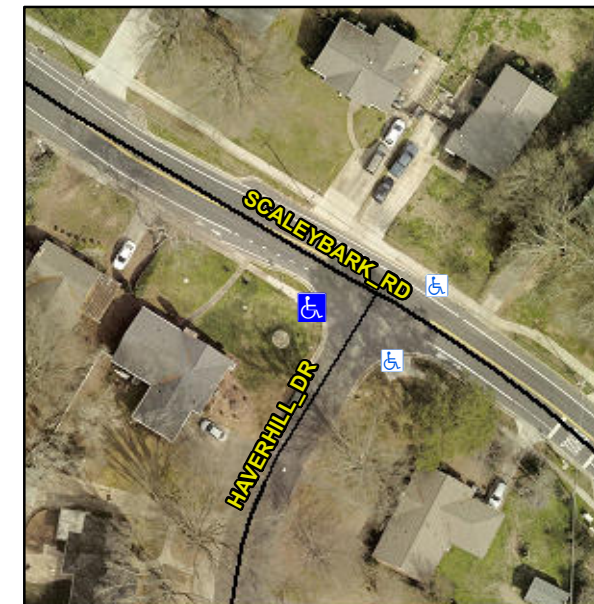
Compliance	Description	Data	Compliance	Description	Data
N/A	Ramp Length (in)	133.0	N/A	Grade Break?	N/A
Yes	Ramp Width (in)	58.5	N/A	Grade Break Slope (%)	0.0
Yes	Ramp Slope (%)	4.2	N/A	Grade Break XSlope (%)	0.0
No	Ramp XSlope (%)	2.8			
N/A	Flare Type LT	N/A	N/A	Flare Type RT	N/A
N/A	Flare Slope LT (%)	N/A	N/A	Flare Slope RT (%)	0.0
N/A	Flare Traversable LT?	N/A	N/A	Flare Traversable RT?	N/A
N/A	Landing Length (in)	0.0	N/A	DWS Provided?	N/A
N/A	Landing Width (in)	0.0	N/A	DWS Contrast?	N/A
N/A	Landing Slope (%)	0.0	N/A	DWS Length (in)	N/A
N/A	Landing X Slope (%)	0.0	N/A	DWS Full Width?	N/A
N/A	Landing Curb? (Y/N)	N/A	N/A	DWS Offset LT (in)	N/A
N/A	Shared Landing?	N/A	N/A	DWS Offset RT (in)	N/A
N/A	Gutter Ponding?	0.0	N/A	Gutter Slope (%)	N/A
N/A	Gutter Lip Ht (in)	0.0	N/A	Gutter X Slope (%)	N/A
N/A	Painted X Walk1?	No		Road Slope (%)	0.8
	X Walk 1 Direction	To SE		Road X Slope (%)	3.3
	X Walk 1 Width (in)	N/A		Clear Space?	N/A

X Walk 1 Slope (%)	0.8	N/A	Clear Space to XWalk (in)	N/A
	X Walk 1 X Slope (%)	3.3	N/A	Storm Grate/Utility Hazard?	N/A
N/A	Ramp inside XWalk1?	N/A		Storm Grate/Utility Type	
N/A	Any Obstructions?	N/A			N/A
	Obstruction Type		Yes	Surface Condition? (G/P)	Good
			N/A	Curb Slope (%)	4.3

Possible Solutions:

**Remove & Replace Entire Ramp.**

**R304.5.3**

\$ 1600.00
