# Access Compliance Report

## Public Rights-of-Way

### (Curb Ramps)

Intersection ID: 13742	Main Street: CRESTSIDE_LN	Cross Street: SCHUBERT_PL	Location: NW
ADA ID: 088FCC7EEE14	Ramp Type: Perp	Initial Pass/Fail: Fail	Overall Compliance: No
Codes/Mitigation Info/Possible Solution		Field Measurements/Component Compliance	
Severity Score: 10

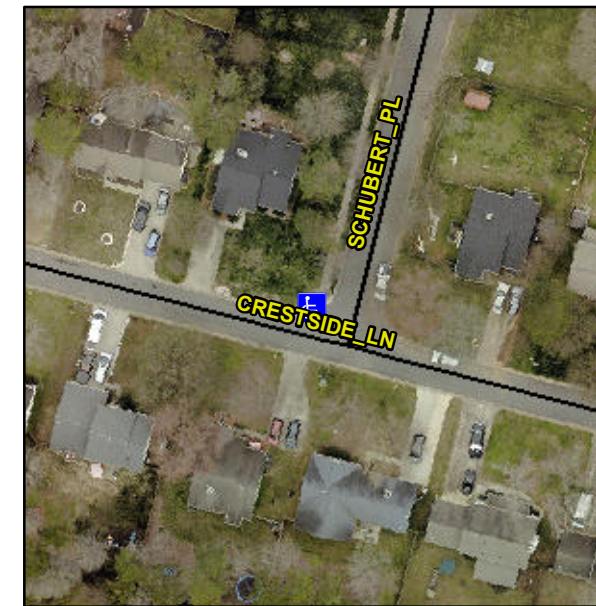
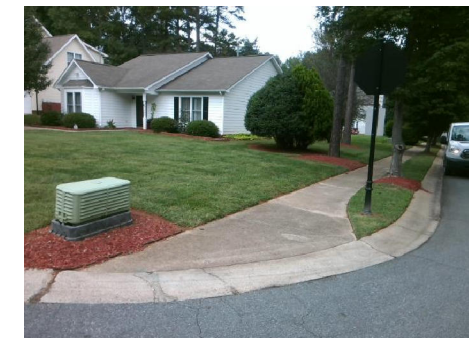
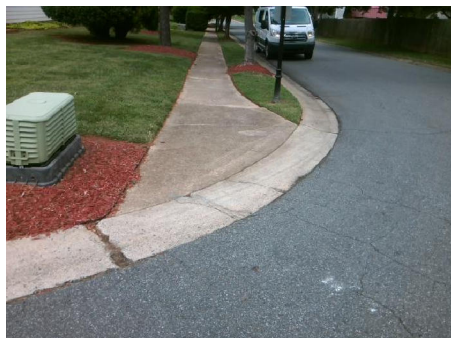
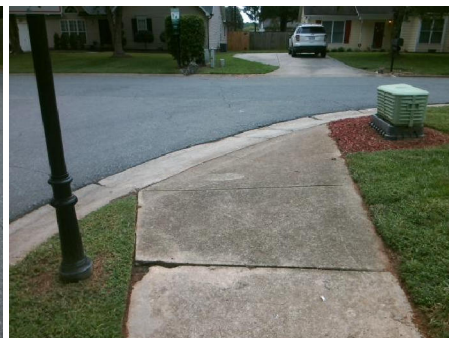
**Not Found, R304.5.1, R304.5.3**

Compliance	Description	Data	Compliance	Description	Data
N/A	Ramp Length (in)	46.5	Yes	Ramp Slope (%)	5.3
No	Ramp Width (in)	47.5	No	Ramp XSlope (%)	3.2
N/A	Flare Type LT	N/A	N/A	Flare Type RT	N/A
N/A	Flare Slope LT (%)	N/A	N/A	Flare Slope RT (%)	N/A
N/A	Flare Traversable LT?	N/A	N/A	Flare Traversable RT?	N/A
N/A	Landing Length (in)	N/A	N/A	DWS Provided?	N/A
N/A	Landing Width (in)	N/A	N/A	DWS Contrast?	N/A
N/A	Landing Slope (%)	N/A	N/A	DWS Length (in)	N/A
N/A	Landing X Slope (%)	N/A	N/A	DWS Full Width?	N/A
N/A	Landing Curb? (Y/N)	N/A	N/A	DWS Offset (in)	N/A
N/A	Shared Landing?	N/A			
N/A	Gutter Ponding?	N/A	N/A	Gutter Slope (%)	N/A
N/A	Gutter Lip Ht (in)	1.0	N/A	Gutter X Slope (%)	N/A
N/A	Painted X Walk1?	No	N/A	Painted X Walk2?	N/A
	X Walk 1 Direction	To SE		X Walk 2 Direction	N/A
N/A	X Walk 1 Width (in)	N/A	N/A	X Walk 2 Width (in)	N/A
	X Walk 1 Slope (%)	5.0		X Walk 2 Slope (%)	N/A
	X Walk 1 X Slope (%)	2.9		X Walk 2 X Slope (%)	N/A

N/A	Ramp inside XWalk1?	N/A	N/A	Ramp inside XWalk2?	N/A
	Road Slope (%)	2.9	N/A	Clear Space?	N/A
	Road X Slope (%)	5.0	N/A	Clear Space to XWalk (in)	N/A
N/A	Any Obstructions?	N/A	N/A	Storm Grate/Utility Hazard?	N/A
	Obstruction Type			Storm Grate/Utility Type	
		N/A			N/A
			Yes	Surface Condition? (G/P)	Good

**Remove & Replace Entire Ramp.**
