Access Compliance Report

Public Rights-of-Way

(Curb Ramps)

Intersection ID: 16241	Main Street: IDLEWOOD_CR	Cross Street: LILAC_RD	Location: NW
ADA ID: 08ACE5F95AC8	Ramp Type: PerpDiag	Initial Pass/Fail: Fail	Overall Compliance: No
		Severity Score: 37.5

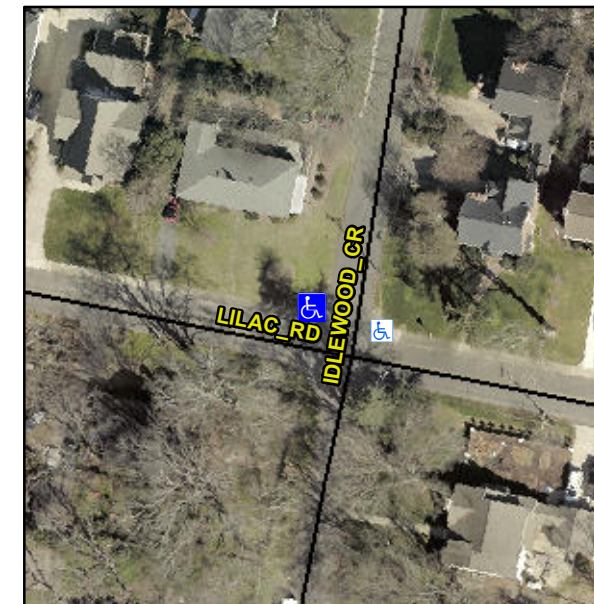
Not Found, R304.2.2, R304.5.3

Compliance	Description	Data	Compliance	Description	Data
N/A	Ramp Length (in)	53.0	No	Ramp Slope (%)	16.6
Yes	Ramp Width (in)	57.0	No	Ramp XSlope (%)	6.6
N/A	Flare Type LT	N/A	N/A	Flare Type RT	N/A
N/A	Flare Slope LT (%)	N/A	N/A	Flare Slope RT (%)	N/A
N/A	Flare Traversable LT?	N/A	N/A	Flare Traversable RT?	N/A
N/A	Landing Length (in)	N/A	N/A	DWS Provided?	N/A
N/A	Landing Width (in)	N/A	N/A	DWS Contrast?	N/A
N/A	Landing Slope (%)	N/A	N/A	DWS Length (in)	N/A
N/A	Landing X Slope (%)	N/A	N/A	DWS Full Width?	N/A
N/A	Landing Curb? (Y/N)	N/A	N/A	DWS Offset (in)	N/A
N/A	Shared Landing?	N/A			
N/A	Gutter Ponding?	N/A	N/A	Gutter Slope (%)	N/A
N/A	Gutter Lip Ht (in)	N/A	N/A	Gutter X Slope (%)	N/A
N/A	Painted X Walk1?	No	N/A	Painted X Walk2?	No
	X Walk 1 Direction	To SW		X Walk 2 Direction	To SE
N/A	X Walk 1 Width (in)	N/A	N/A	X Walk 2 Width (in)	N/A
	X Walk 1 Slope (%)	5.9		X Walk 2 Slope (%)	0.2
	X Walk 1 X Slope (%)	1.4		X Walk 2 X Slope (%)	5.6

N/A	Ramp inside XWalk1?	N/A	N/A	Ramp inside XWalk2?	N/A
	Road Slope (%)	2.6	N/A	Clear Space?	N/A
	Road X Slope (%)	5.5	N/A	Clear Space to XWalk (in)	N/A
N/A	Any Obstructions?	N/A	N/A	Storm Grate/Utility Hazard?	N/A
	Obstruction Type			Storm Grate/Utility Type	
		N/A			N/A
			Yes	Surface Condition? (G/P)	Good

Remove & Replace Curb Ramp With Two New Directional Ramps or Equivalent.
