Access Compliance Report

Public Rights-of-Way

(Curb Ramps)

Intersection ID: 9705	Main Street: CADMIUM_CT	Cross Street: OCHRE_DR	Location: SW
ADA ID: 08AE1A857772	Ramp Type: Directional1	Initial Pass/Fail: Fail	Overall Compliance: No
Codes/Mitigation Info/Possible Solution		Field Measurements/Component Compliance	
Severity Score: 21.25

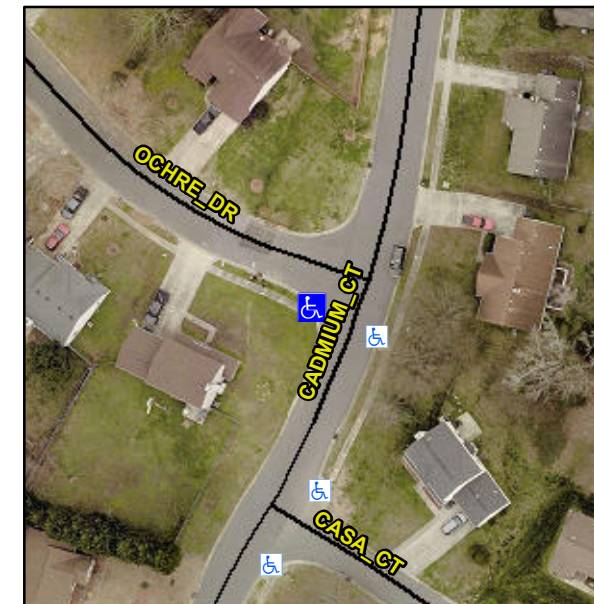
Compliance	Description	Data	Compliance	Description	Data
N/A	Ramp Length (in)	67.0	N/A	Grade Break?	N/A
No	Ramp Width (in)	47.5	N/A	Grade Break Slope (%)	0.0
No	Ramp Slope (%)	9.8	N/A	Grade Break XSlope (%)	0.0
Yes	Ramp XSlope (%)	0.1			
N/A	Flare Type LT	N/A	N/A	Flare Type RT	N/A
N/A	Flare Slope LT (%)	N/A	N/A	Flare Slope RT (%)	0.0
N/A	Flare Traversable LT?	N/A	N/A	Flare Traversable RT?	N/A
N/A	Landing Length (in)	0.0	N/A	DWS Provided?	N/A
N/A	Landing Width (in)	0.0	N/A	DWS Contrast?	N/A
N/A	Landing Slope (%)	0.0	N/A	DWS Length (in)	N/A
N/A	Landing X Slope (%)	0.0	N/A	DWS Full Width?	N/A
N/A	Landing Curb? (Y/N)	N/A	N/A	DWS Offset LT (in)	N/A
N/A	Shared Landing?	N/A	N/A	DWS Offset RT (in)	N/A
N/A	Gutter Ponding?	0.0	N/A	Gutter Slope (%)	N/A
N/A	Gutter Lip Ht (in)	1.0	N/A	Gutter X Slope (%)	N/A
N/A	Painted X Walk1?	No		Road Slope (%)	2.1
	X Walk 1 Direction	To SE		Road X Slope (%)	12.2
	X Walk 1 Width (in)	N/A		Clear Space?	N/A

X Walk 1 Slope (%)	2.1	N/A	Clear Space to XWalk (in)	N/A
	X Walk 1 X Slope (%)	12.2	N/A	Storm Grate/Utility Hazard?	N/A
N/A	Ramp inside XWalk1?	N/A		Storm Grate/Utility Type	
N/A	Any Obstructions?	N/A			N/A
	Obstruction Type		Yes	Surface Condition? (G/P)	Good
			N/A	Curb Slope (%)	34.5

Possible Solutions:

Remove & Replace Entire Ramp.

R304.5.1, R304.2.2
