Access Compliance Report

Public Rights-of-Way

(Curb Ramps)

Intersection ID: 48497	Main Street: SOLAR_WY	Cross Street: CASTLECOVE_RD	Location: SW
ADA ID: 08B3F4E95838	Ramp Type: PerpDiag	Initial Pass/Fail: Fail	Overall Compliance: No
Severity Score: 8.75			
Codes/Mitigation Info/Possible Solution		Field Measurements/Component Compliance

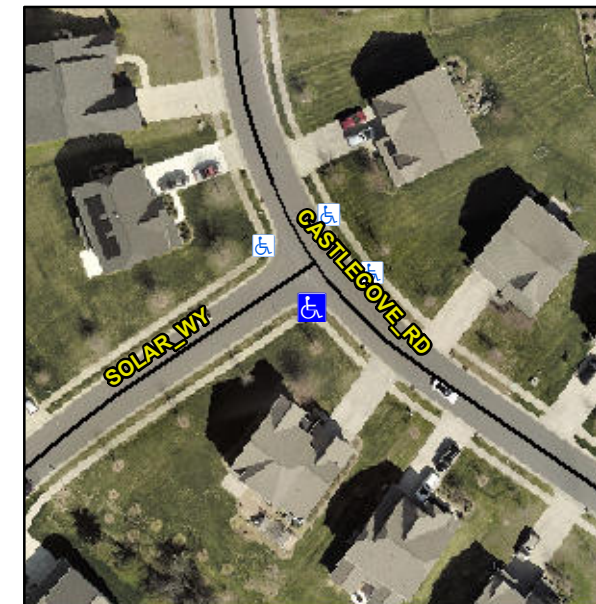
Not Found, R304.5.1

Compliance	Description	Data	Compliance	Description	Data
N/A	Ramp Length (in)	47.0	Yes	Ramp Slope (%)	7.1
No	Ramp Width (in)	46.5	Yes	Ramp XSlope (%)	1.7
N/A	Flare Type LT	N/A	N/A	Flare Type RT	N/A
N/A	Flare Slope LT (%)	N/A	N/A	Flare Slope RT (%)	N/A
N/A	Flare Traversable LT?	N/A	N/A	Flare Traversable RT?	N/A
N/A	Landing Length (in)	N/A	N/A	DWS Provided?	N/A
N/A	Landing Width (in)	N/A	N/A	DWS Contrast?	N/A
N/A	Landing Slope (%)	N/A	N/A	DWS Length (in)	N/A
N/A	Landing X Slope (%)	N/A	N/A	DWS Full Width?	N/A
N/A	Landing Curb? (Y/N)	N/A	N/A	DWS Offset (in)	N/A
N/A	Shared Landing?	N/A			
N/A	Gutter Ponding?	N/A	N/A	Gutter Slope (%)	N/A
N/A	Gutter Lip Ht (in)	N/A	N/A	Gutter X Slope (%)	N/A
N/A	Painted X Walk1?	No	N/A	Painted X Walk2?	No
	X Walk 1 Direction	To NE		X Walk 2 Direction	To NW
N/A	X Walk 1 Width (in)	N/A	N/A	X Walk 2 Width (in)	N/A
	X Walk 1 Slope (%)	2.2		X Walk 2 Slope (%)	2.1
	X Walk 1 X Slope (%)	1.9		X Walk 2 X Slope (%)	0.9

N/A	Ramp inside XWalk1?	N/A	N/A	Ramp inside XWalk2?	N/A
	Road Slope (%)	2.9	N/A	Clear Space?	N/A
	Road X Slope (%)	0.3	N/A	Clear Space to XWalk (in)	N/A
N/A	Any Obstructions?	N/A	N/A	Storm Grate/Utility Hazard?	N/A
	Obstruction Type			Storm Grate/Utility Type	
		N/A			N/A
			Yes	Surface Condition? (G/P)	Good

Remove & Replace Curb Ramp With Two New Directional Ramps or Equivalent.

Total Cost: \$ 3200.00
