# Access Compliance Report

## Public Rights-of-Way

### (Curb Ramps)

| Intersection ID: 53390 | Main Street: KELBURN_LN | Cross Street: AGNEW_DR | Location: NW |

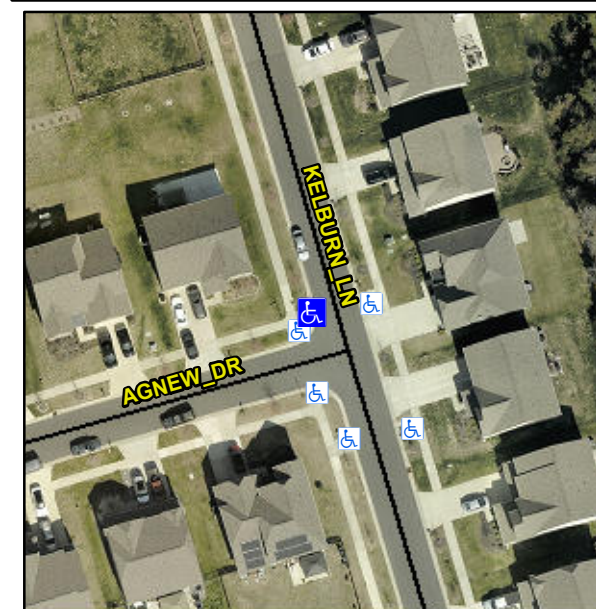
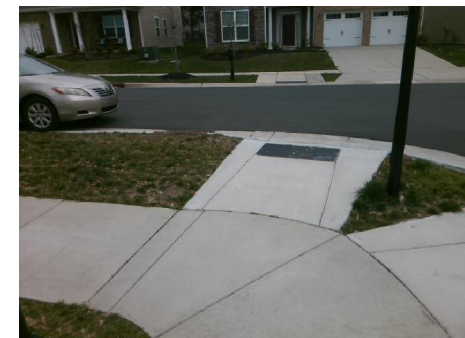
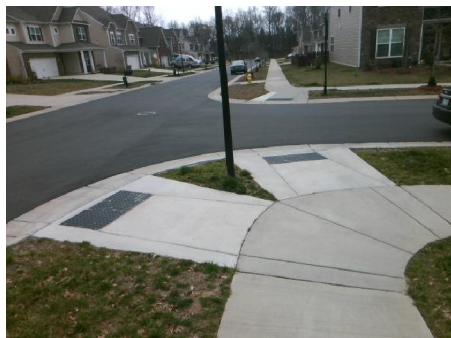
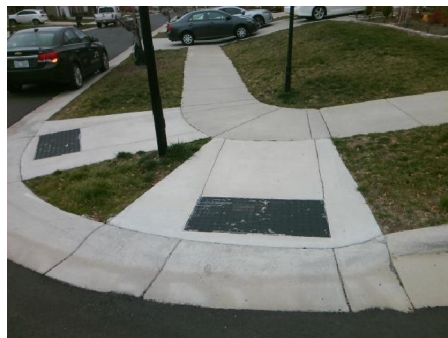
| ADA ID: 08C20B964598 | Ramp Type: BlendTrans1 | Initial Pass/Fail: Fail | Overall Compliance: No |

**R304.5.1, R304.5.3**

| Compliance | Description | Data | Compliance | Description | Data |
|---|---|---|---|---|---|
| N/A | Ramp Length (in) | 97.0 | Yes | BlendTrans Slope (%) | 3.8 |
| No | Ramp Width (in) | 46.5 | No | BlendTrans XSlope (%) | 3.6 |

**Remove & Replace Curb Ramp With Two New Directional Ramps or Equivalent.**
